# HIGH DALMUIR CONSERVATION AREA APPRAISAL

June 2017

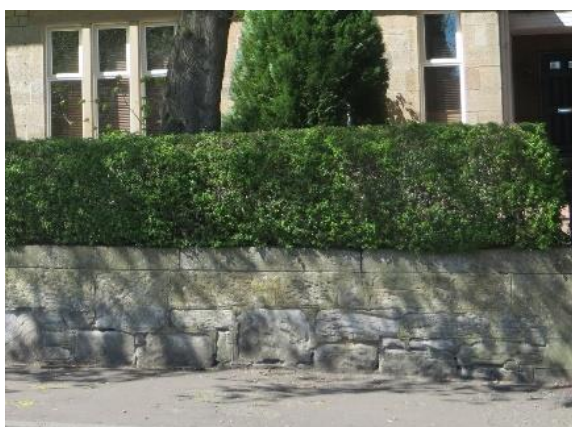
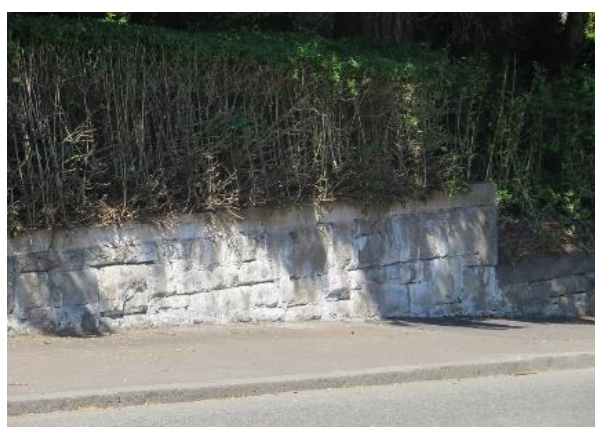
Some sections of boundary walls are in poor condition or repaired inappropriately including use of cement mortar and 'plastic' stone repairs. There is stone erosion at the pavement level due to water splashback, and salt efflorescence from continued wetting and drying of the sandstone. Where boundary walls also act as retaining walls to gardens, several have weep holes built in. Where absent this may also cause salt efflorescence

Figure 14 Left: Boundary wall with erosion. Right: Boundary wall with salt efflorescence.

Several buildings and boundary walls appear to have cement-based repairs. Attention should be drawn to the risk associated with impermeable materials and finishes and opportunities taken to repair in traditional materials when they arise.
