# Gruggies Burn Flood Alleviation Scheme

## Historic Environment Assessment

# Gruggies Burn Flood Alleviation Scheme, Dumbarton

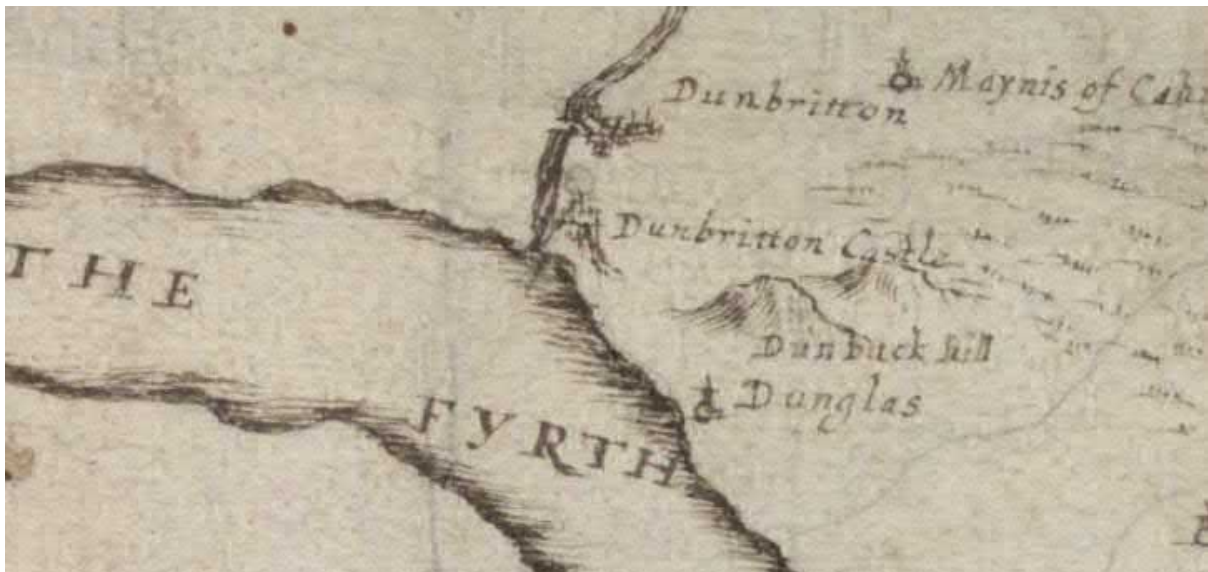
Illustration 2: Extract from Pont's map of 1583 to 1596 showing 'Dunbritton Castle'. Courtesy of the National Library of Scotland.

The earliest known maps that exist of Scotland are those made by Timothy Pont in the late 1500s. Pont's map of 1583 to 1596 shows 'Dunbritton Castle' (Illus. 2) but depicts no useful detail of the development area. The same can be said for the slightly later maps by Robert Gordon (1636-1652) and

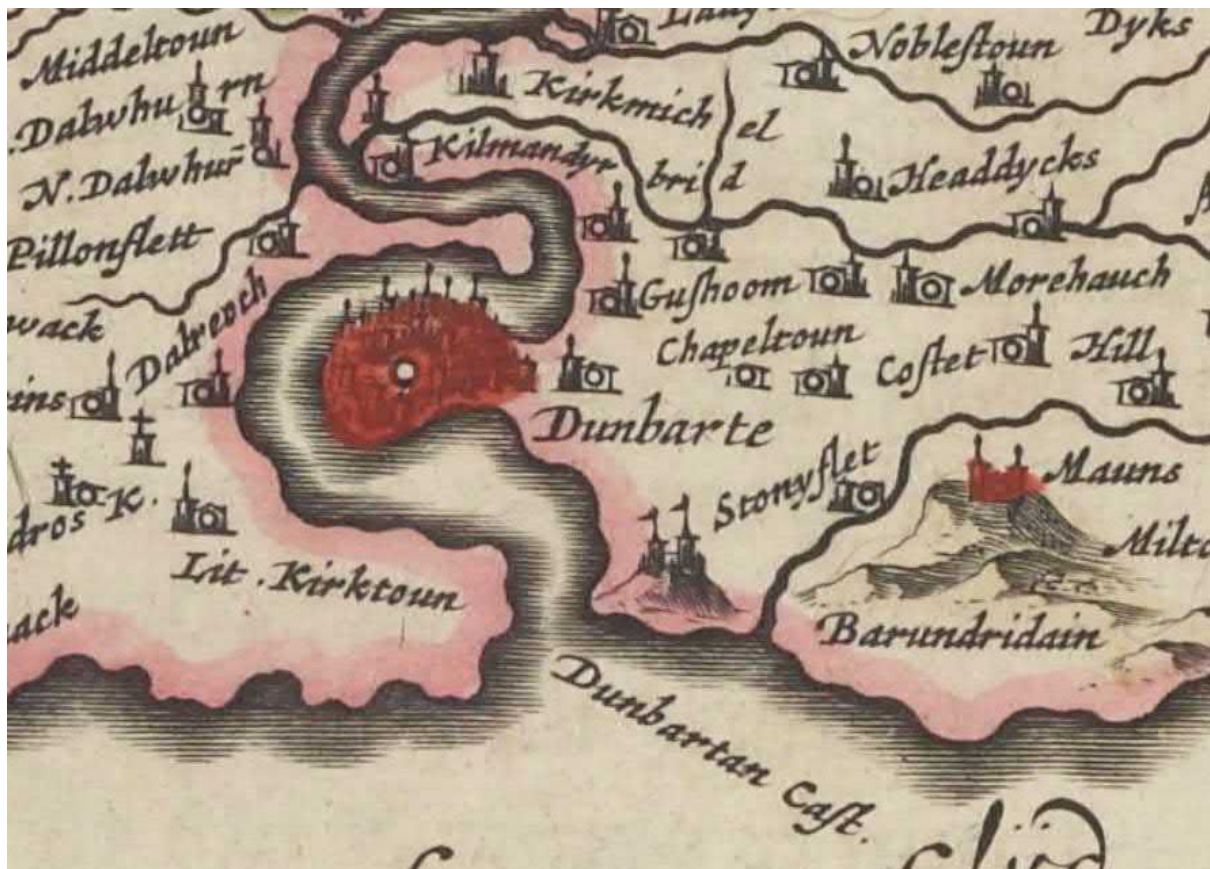
Illustration 3: Extract from Blaeu's map of 1654 showing 'Dunbartan' Castle and a burn to the east. Courtesy of the National Library of Scotland.

Joan Blaeu (1654) which were largely based on Pont's earlier work, although Blaeu's map does depict a burn to the east which may be Gruggies Burn (Illus. 3).

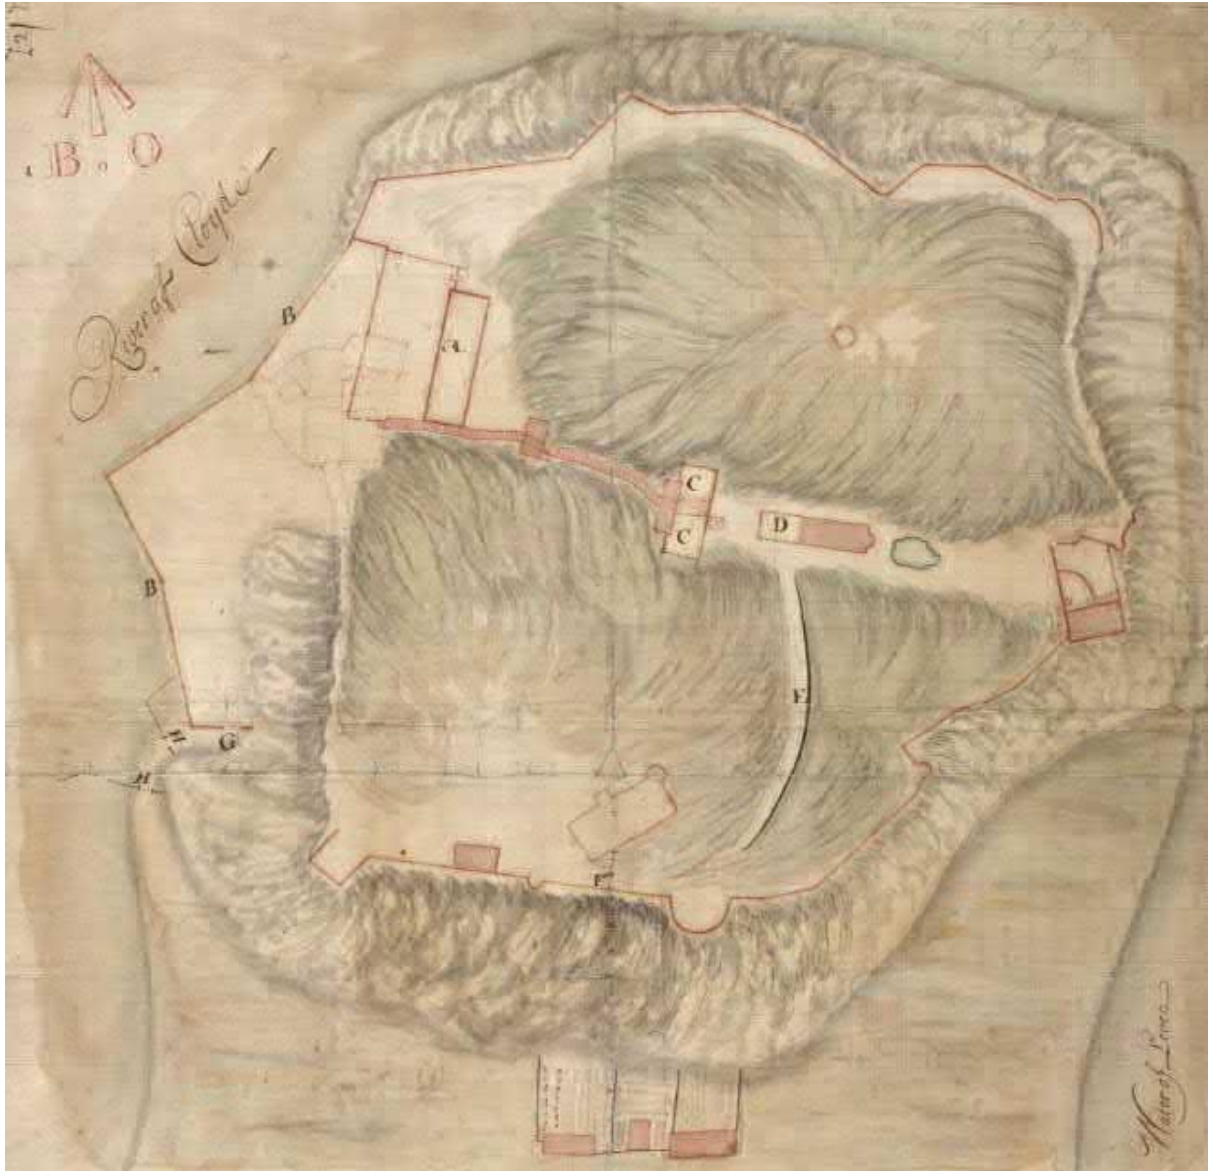
A detailed map of proposed repairs to Dumbarton Castle produced in the early 18<sup>th</sup> century (O'Brien 1709) maps two outer gates just south of the location of the proposed flood barriers (Illus. 4).

*Illustration 4: Extract of a plan of the Castle produced by engineer John O'Brien in 1709 showing outer barriers (H) to the south of the proposed flood alleviation barriers. Courtesy of the national Library of Scotland.*

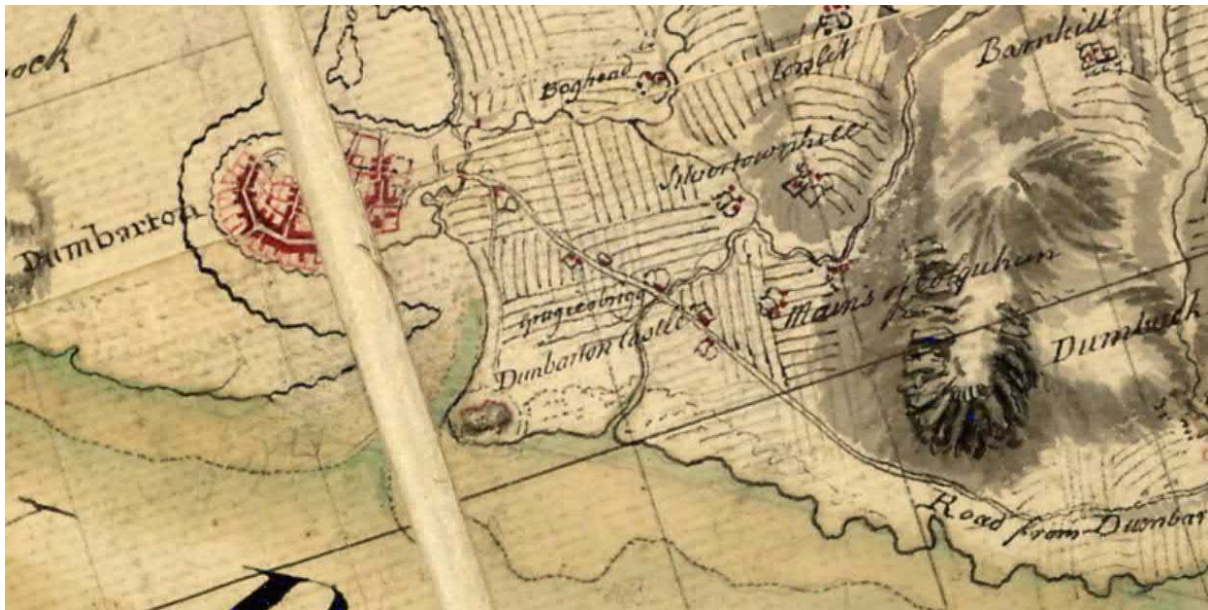
Illustration 5: Extract from General Roy's military survey (1752-55). Courtesy of the National Library of Scotland & the British Museum.

Moll's map of 1745 shows no detail of the proposed development area. However, General Roy's military survey of the lowlands, also from the mid-18<sup>th</sup> century (1752-55), shows Dumbarton Castle, the Gruggies Burn and some sparse settlement and cultivated fields either side of what is now the A814 (Illus. 5).

One of these settlements is located where the road crosses the Gruggies burn and is called 'Gruggiesbrigg'. Nothing is mapped along the coastline to the east of the Castle and Gruggies Burn.

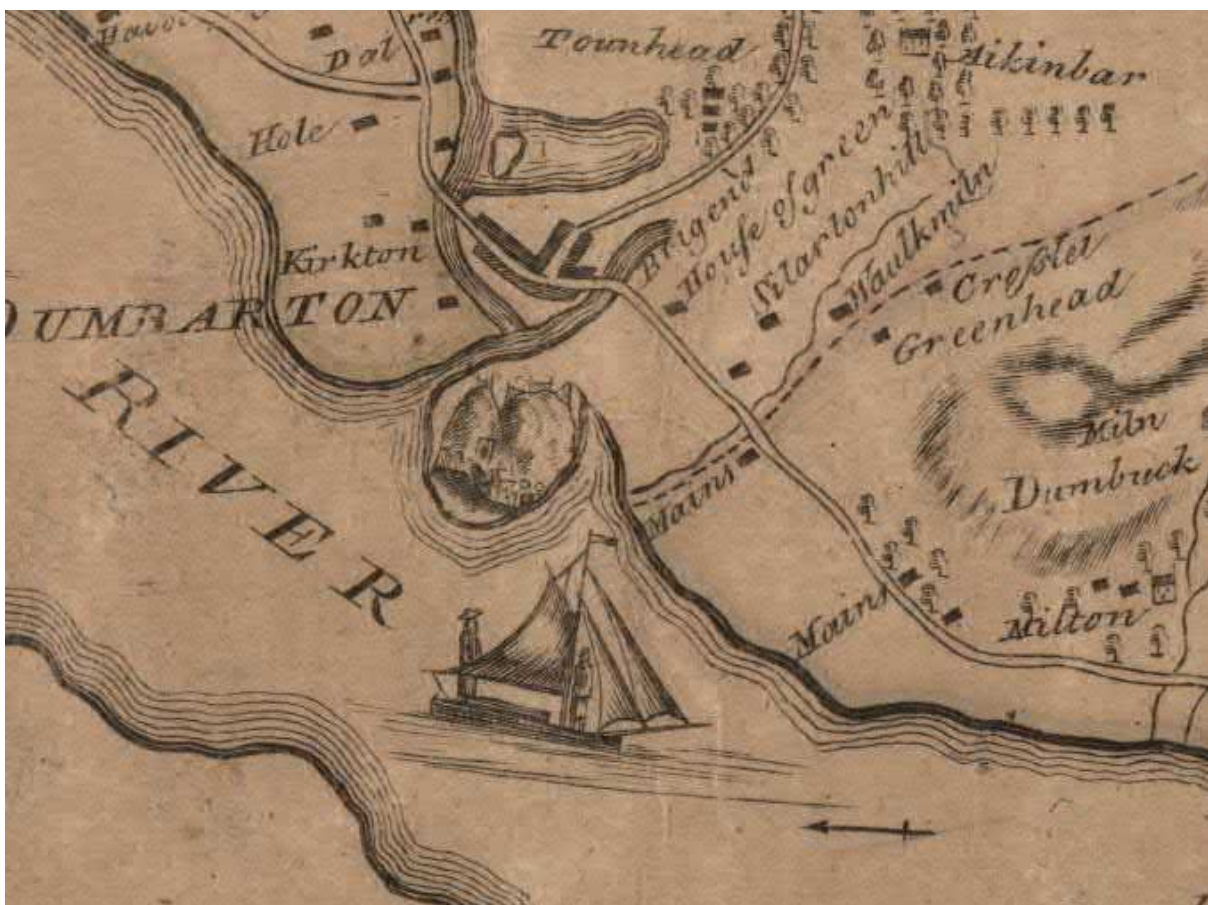
Illustration 6: Extract from Ross's map of 1777 showing Dumbarton Rock and a burn to the east. Courtesy of the National Library of Scotland.

Ross's map of 1777 (Illus. 6) shows Dumbarton Rock and a small burn to the east which is likely the Gruggies Burn. A detailed map of Dumbarton and Dumbarton Rock was produced in 1818 by John Wood which shows no features at the location of the proposed flood barriers at Dumbarton Castle (Illus. 7). An inset on Thomson's map of 1822 also shows a similar plan of the castle. A map drawn up by parliament in 1832 shows the Castle and lower reaches of the Gruggies Burn in detail (Illus. 8) but does not map any specific features with the proposed flood alleviation area.

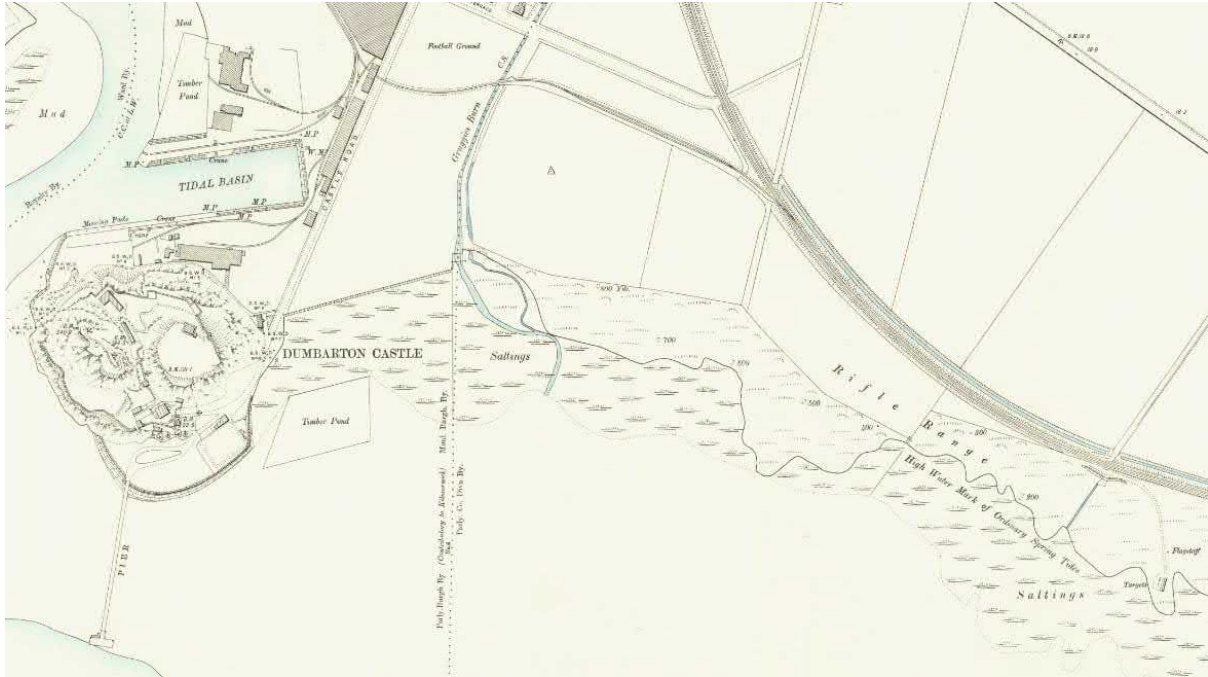
*Illustration 10: Extract of the first revision OS 25 inch to the mile map revised in 1896 and published 1897 showing a rifle range along the shore to the east of the Gruggies Burn and south of the Hunter's Burn (Asset 50) and the shipyard basin north of Dumbarton Roack (Asset 12). Courtesy of the National Library of Scotland.*

A rifle range (**Asset 50**) shown on the first revision OS 6 inch and 25 inch to the mile map revised in 1896 (Illus. 10) crosses the mouth of Hunter's Burn and the southern end of the proposed flood relief culvert. However, the flagstaff, target and the vast majority of the range lies outwith the boundaries of the proposed flood alleviation scheme.

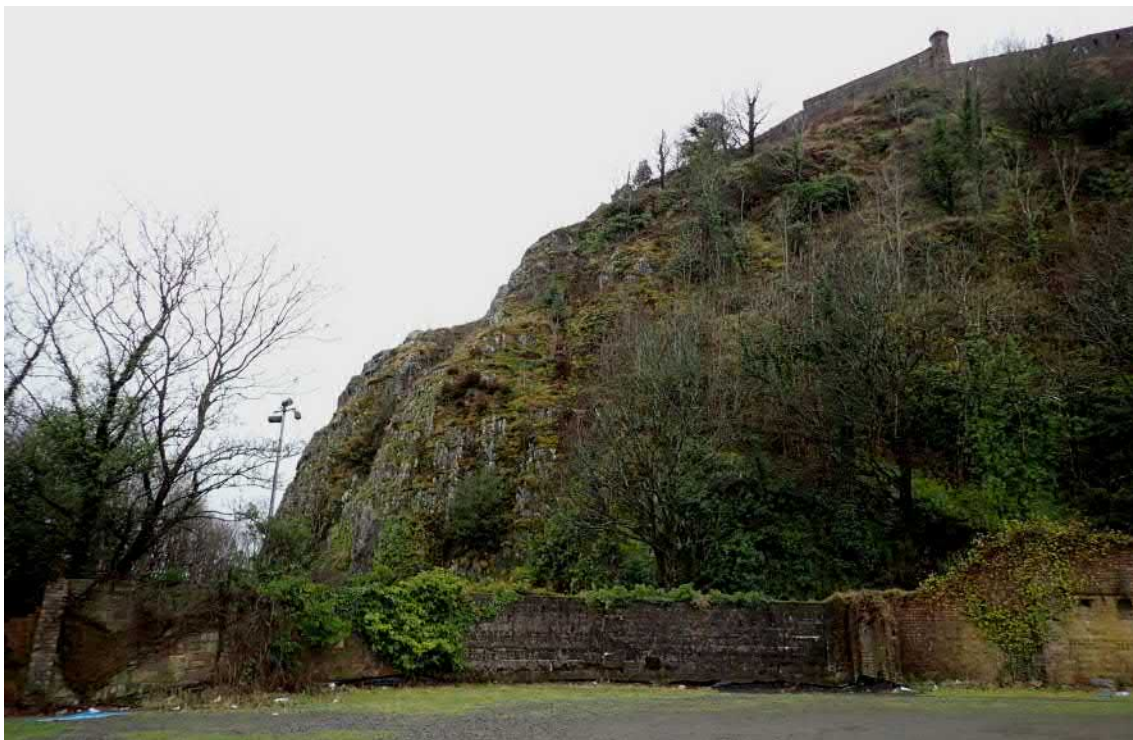
*Illustration 12: remains of likely shipyard boundary walls (Asset 12) below Dumbarton Rock.*

Walls likely belonging to a former shipyard (**Asset 12**) are present in the western part of the northern potential flood gate location on Castle Road (Illus. 11). The remains of the former boundary wall survive up to 2m in height and is composed variously of brick and stone sections with some brick abutments on the northern side (Illus. 12). It lies in the south-eastern corner of the former William Denny and Brothers shipyard which would have also included numerous buildings and a tidal basin all of which are visible on OS maps from the late 19<sup>th</sup> century onwards. Some small sections of older dressed sandstone present in the boundary wall could relate to boundary walls that formed part of Castle Green House, which sat north of the castle prior to the expansion of the shipyard in the mid-19<sup>th</sup> century, however, it is also feasible that the wall relates entirely to various phases of the shipyard. The main shipyard area has now been redeveloped as a football stadium.

As all the historic environment assets recorded within the proposed flood alleviation scheme are considered to be of lesser value it is recommended they do not need to be avoided during future construction works, although unnecessary disturbance should be avoided.

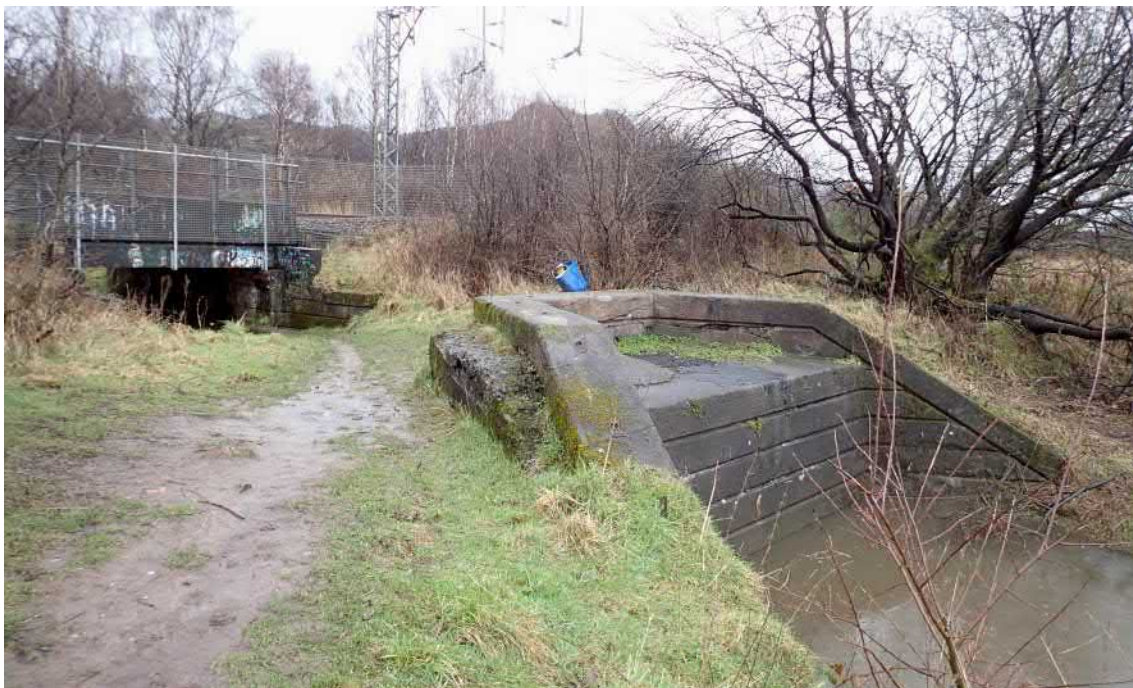
*Illustration 13: Railway bridge and outflow (Asset 49) at Hunter's Burn.*

A very low underpass/bridge (**Asset 49**) carries the current railway across Hunter's Burn. The bridge is constructed of concrete, stone and brick and may contain parts of the original late 19<sup>th</sup> century bridge that formed part of the Lanarkshire and Dumbartonshire railway. A stone and concrete structure to the south (Illus. 13) likely relates to the outflow of the Hunter's Burn and a track which is shown here on the OS 25 inch to the mile map revised in 1896 (Illus. 10). The bridge contains some limited modern graffiti which is referenced in the NRHE.

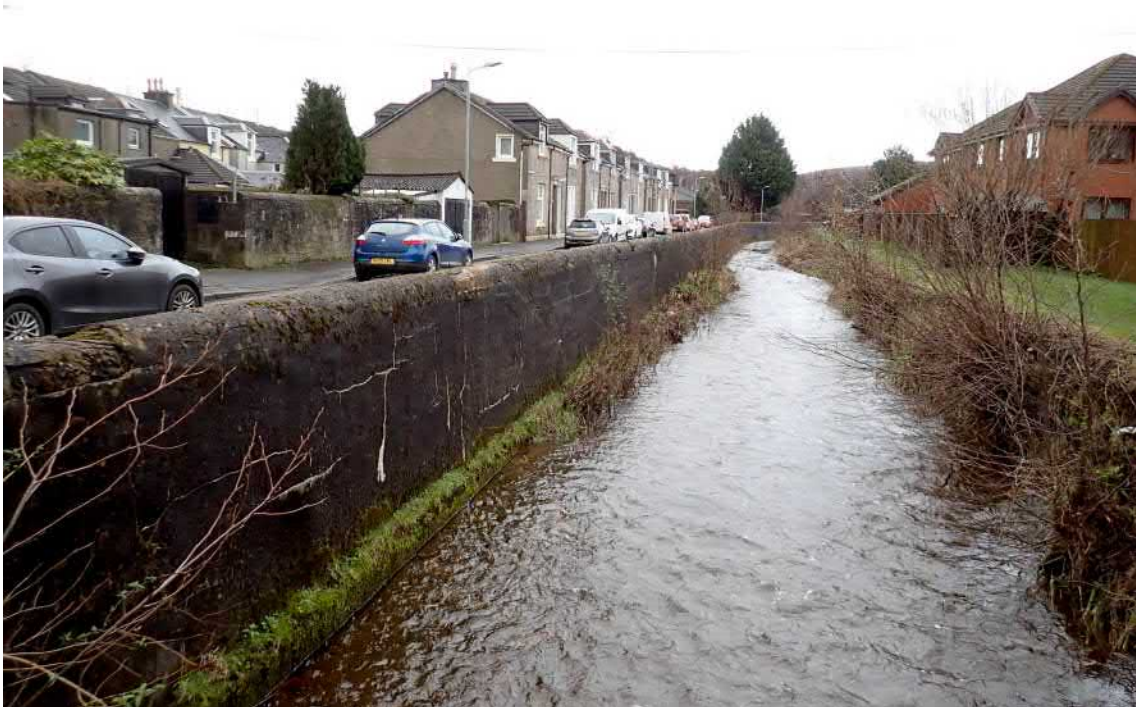
More specifically the Gruggies Burn south of Glasgow Road where tidal walls are proposed appears to have been canalised to some extent. Gabion baskets and stone/concrete walls can be seen lining many of it's edges.

*Illustration 15: Existing concrete walls along the edge of the Gruggies Burn at the eastern side of Knoxland Square Conservation Area.*
