# KNOXLAND SQUARE CONSERVATION AREA APPRAISAL

June 2017

*This document was prepared by the Scottish Civic Trust and Sonya Linskaill, Chartered Architect and Consultant.*

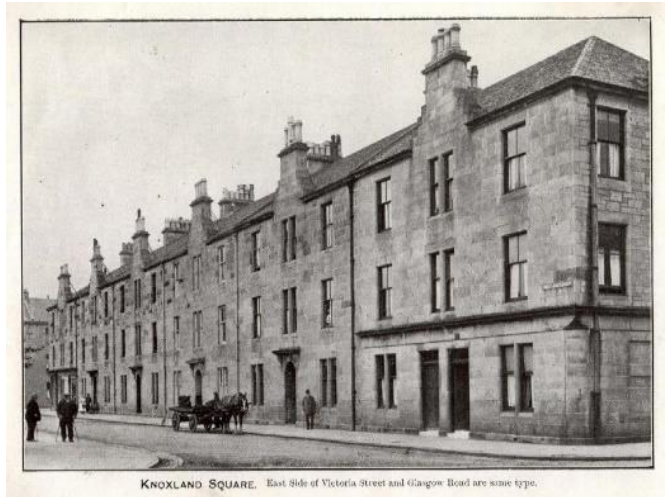
*Figure 4 Knoxland Square north side – Nos. 1-15 tenement designed by John Black before 1897. Image courtesy of West Dunbartonshire Council Libraries & Cultural Services.*

Properties with front gardens similarly create enclosure using low stone boundary walls originally with railings (see Figure 4). No original railings appear to survive although there are original gates on Victoria Street. Here replacement railings appear to have been installed over the length of the terrace which creates continuity although they are significantly less decorative than the original gates. Replacement too on the Knoxland Square terrace is fairly continuous although there have been subsequent replacements and removals and some hedging exists. Some small sections of boundary treatments can detract including concrete block walling or timber fencing.

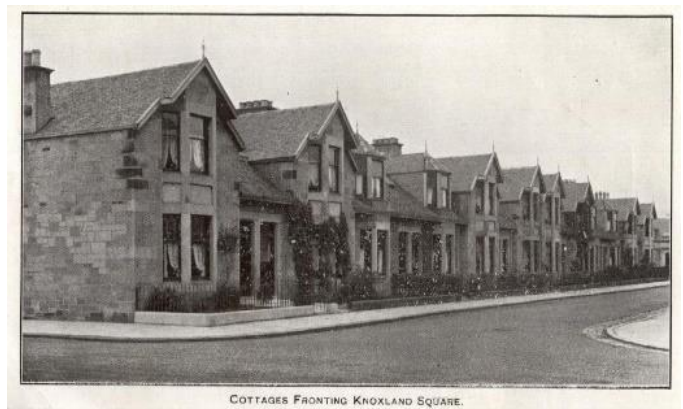
*Figure 5 Knoxland Square south side – Nos. 2-24 terraced houses designed by George Budge c. 1898 Image courtesy of West Dunbartonshire Council Libraries & Cultural Services.*

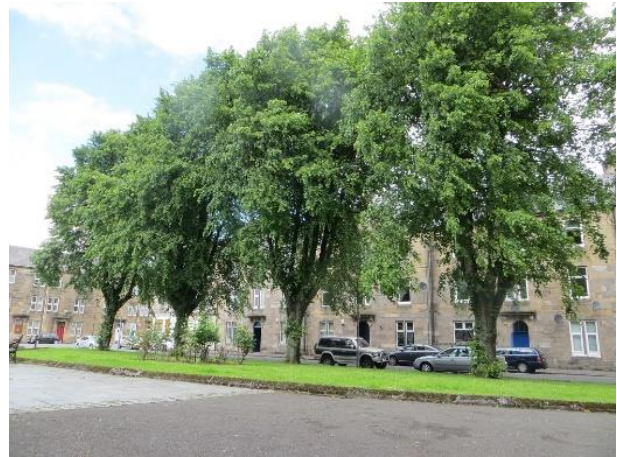
The conservation area is focused on Knoxland Square, an open public space comprised of both green space (mature trees and landscaping) and hard landscaping. The square was gifted to the town in 1890 and originally had a large bandstand (see Figure 10). The central space remains with some benches but has a somewhat barren feel without its central focus. Surrounding the paved central area are mature lime trees (possibly original), five each on the north and south sides and one on the west side. On the

*Figure 11 Mature Lime trees on north of Knoxland Square.*

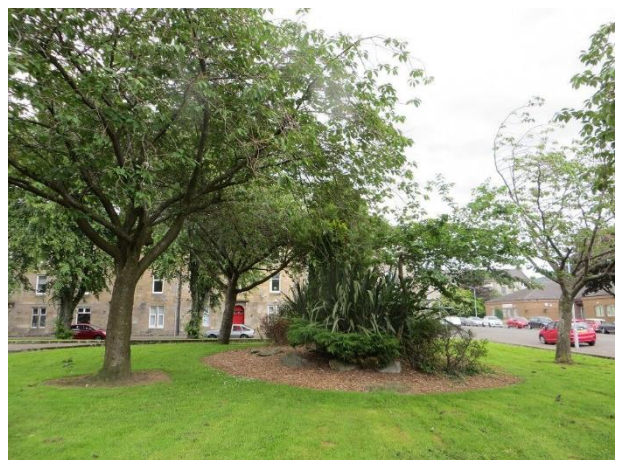
*Figure 12 Mature ornamental fruit trees on east side of square.*

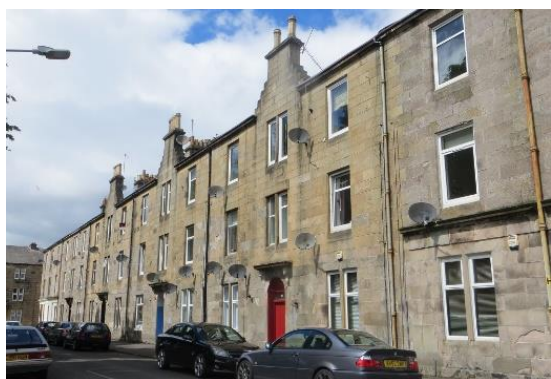
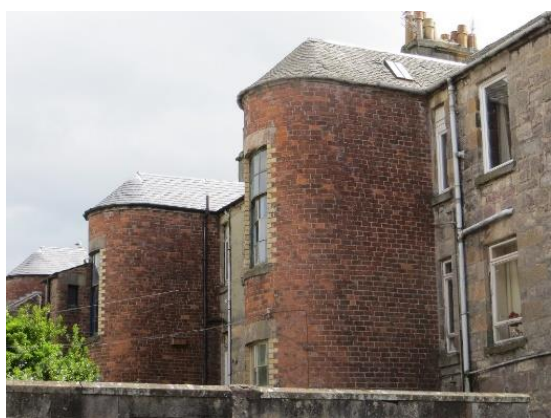
### Nos. 1-15 Knoxland Square (north side)

This northern section of Knoxland Square consists of blond sandstone three-storey tenements designed by John Black in the mid-1890s (Gifford 2002). On the street frontage, each of the six tenements had a central stepped gable chimney rising above the eaves line with an arched close entrance off the street below (2 front chimneys removed). There are corbelled lintels above each close. (This design repeats on the west of this street block on Victoria Street and on Glasgow Road, the latter without the elaborated entrances). There are distinctive semi-circular brick turnpike stairs to rear, most with their original curved glass windows. Roofs are pitched with piend ends to the block, a slightly projecting eaves course, and stout central party wall chimney stacks. The tenements on the west side of **Victoria Street (Nos. 14 – 24)** were built after 1897, repeating the corbelled lintels above close entries but without the stepped chimneys or arched doorways.

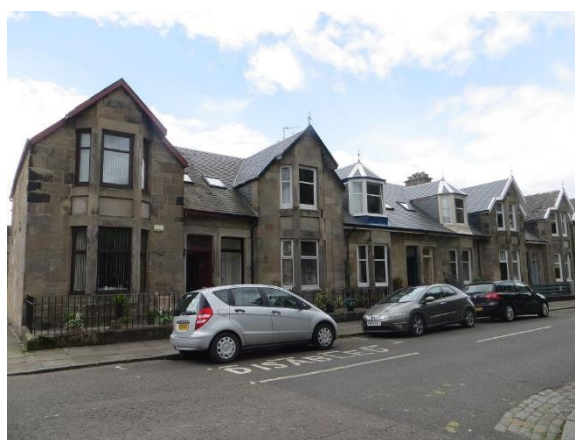
### Nos. 2-24 Knoxland Square (south side)

This southern section of Knoxland Square is more evidently turn of the century in style consisting of a full terrace block designed as one set piece by George Budge 1897-9 (Gifford, 2002). The blond sandstone frontage is dominated by its 2-storey gable fronted canted bays interspersed with lower single storey sections which have canted bay piend dormers. The houses are grouped in pairs, which with the two different house designs creates an attractive articulated roofline and façade. Roofs are pitched with projecting eaves course, cast iron finials, and stout central party wall chimney stacks. Most of the original windows have been replaced but, where remaining, show the original one over one fenestration pattern with horns to the upper sash. Short front gardens enclosed by railings and hedging lead to timber 4-panel doors with rectangular laylights above.

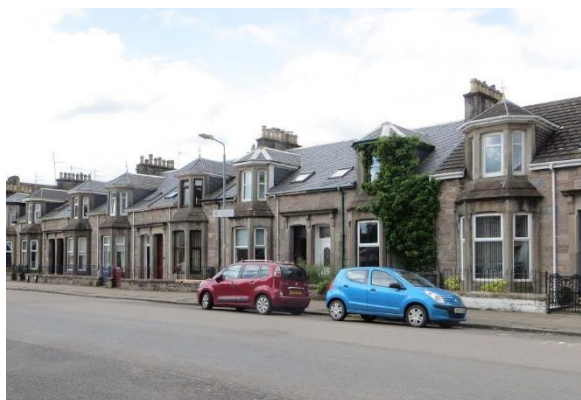
### Nos. 26-42 Victoria Street Not listed

On the south-west side of Knoxland Square this terrace was built after 1897. Constructed in blond sandstone of one and a half storeys with piend canted eaves dormers extending from canted bay windows below. Detailing is similar to the tenements with corbelled lintels above paired entrances. Roofs are pitched with slightly projecting eaves course, cast iron finials, and slender central party wall chimney stacks. Most of the original windows have been replaced but, where remaining, show the original one over one fenestration pattern with horns to the upper sash. Short front gardens enclosed by replacement railings lead to timber panelled doors with rectangular laylights above. The originally very decorative ironwork railings are gone however the original gates remain in the majority of cases.

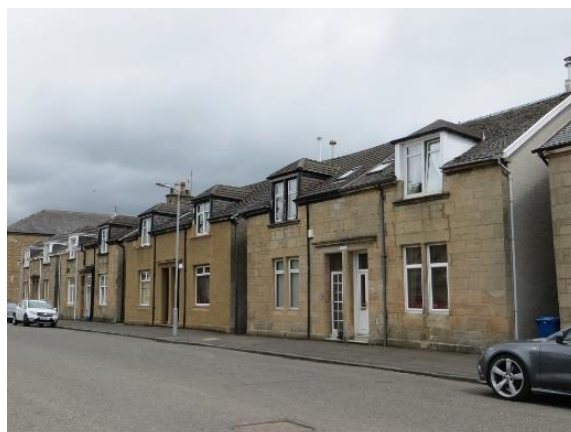
### 9-25 Bruce Street Not listed

On the south-east side of Knoxland Square this terrace was constructed by 1897 and designed as small semi-detached villas with narrow pends between each, built on the street line. Constructed in blond sandstone of one and a half storeys these modest houses are of the same design as those on Buchanan Street and the west side of Wallace Street. The entrances are paired with piend eaves dormers. Detailing is kept simple with projecting stone door lintels and dormer cills. Roofs are pitched with slightly projecting eaves course and gable chimney stacks (several removed). Bipartite windows on the front elevation (some with central mullion removed; all of the original windows have been replaced). Original entrances had rectangular laylights over double timber boarded storm doors and internal part-glazed door. A few storm doors survive and there are further examples on Buchanan and Wallace Streets.

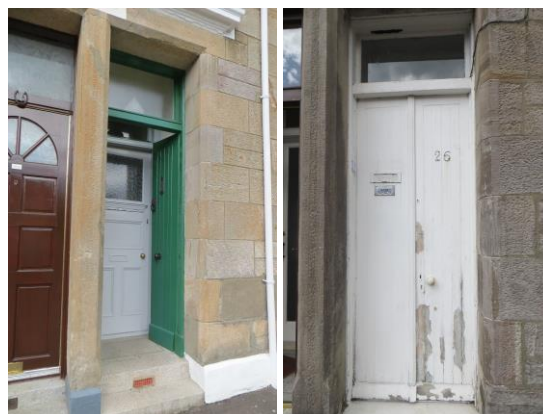
Figure 13 Original door design on Buchanan Street.

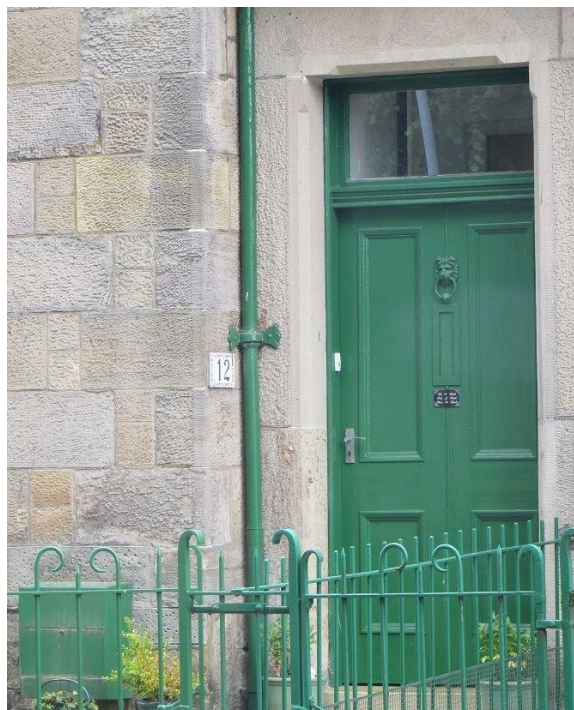
Similarly to windows, few original entrance doors remain. Examples suggest there were double timber boarded doors on Bruce Street, and 4-panel doors on the south side of Knoxland Square and Victoria Street. All with lay lights above, those to the tenements originally with semi-circular fanlights.

*Figure 14 Door on Knoxland Terrace.*

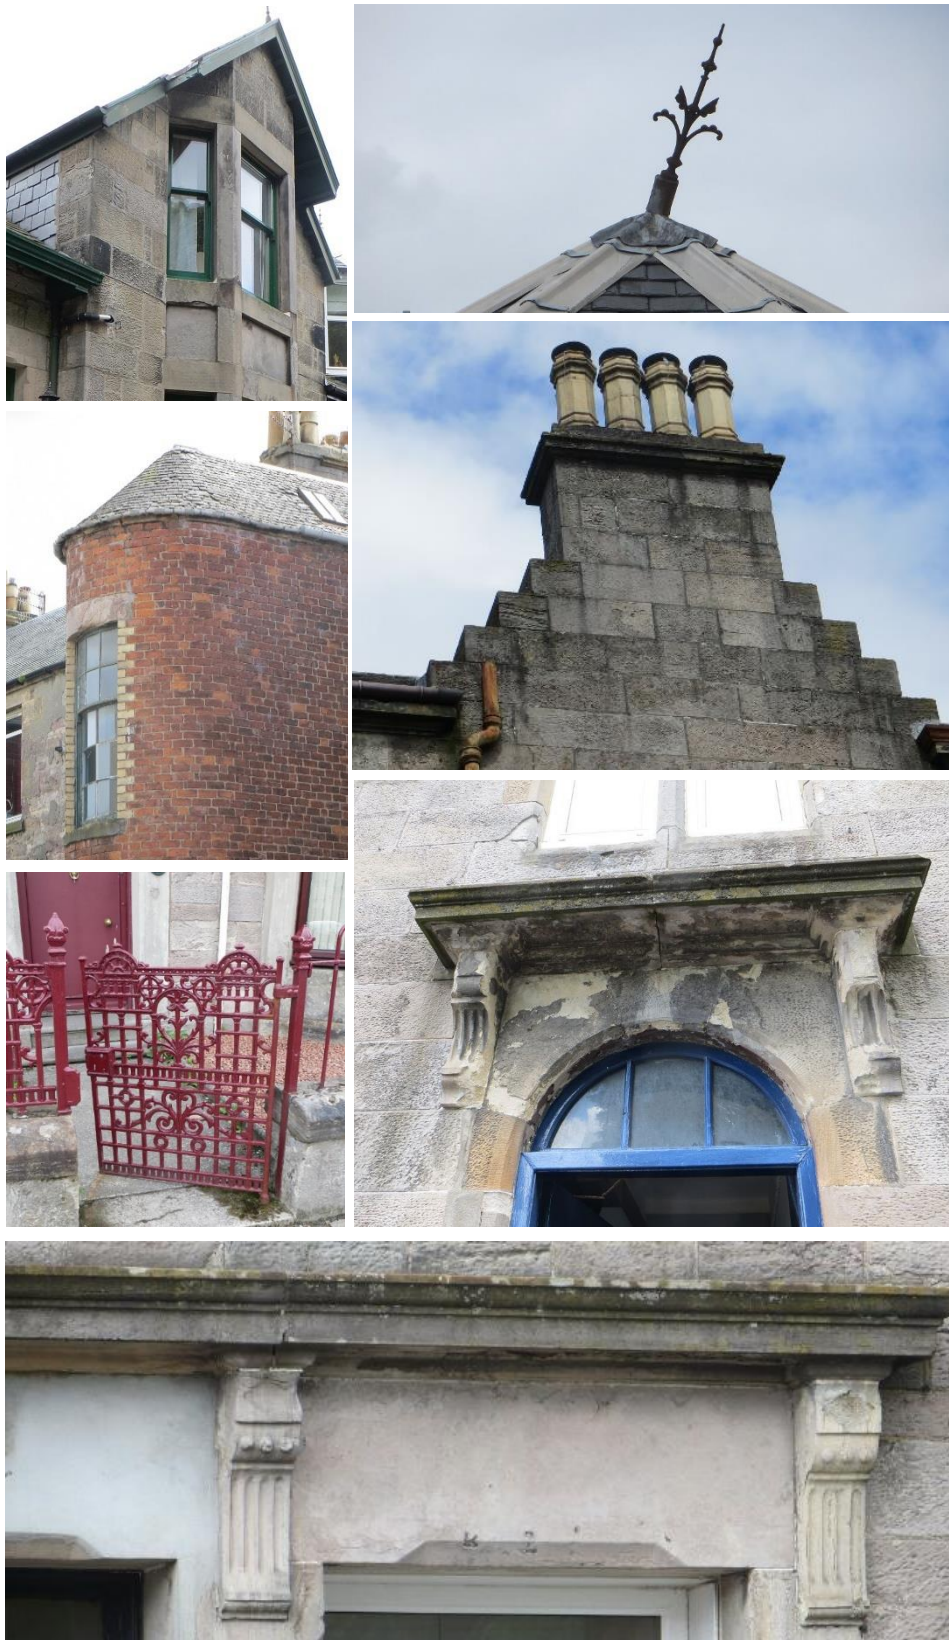
Projecting canted window bays are common on later properties, i.e. on the south side of Knoxland Square and Victoria Street, but not present on the tenements or the earlier houses on Bruce Street. Windows are vertically proportioned; however, very few examples of original timber windows survive. The rear stair towers of the tenements on Knoxland Square retain original, now quite rare, curved timber sash and case windows with astragals (e.g. six over nine, and four over six panes).

*Figure 15 Clockwise from top left: Bay window with original timber sash and case windows, south side of Knoxland Square; finial detail; stepped front chimney on Knoxland Square tenement; corbelled lintel over tenement entrance, Knoxland Square; lintel detail on Victoria Street; decorative cast iron gate on Victoria Street terrace; red brick stair tower to the rear of Knoxland Square with original curved timber sash and case windows and Scots slate roof.*

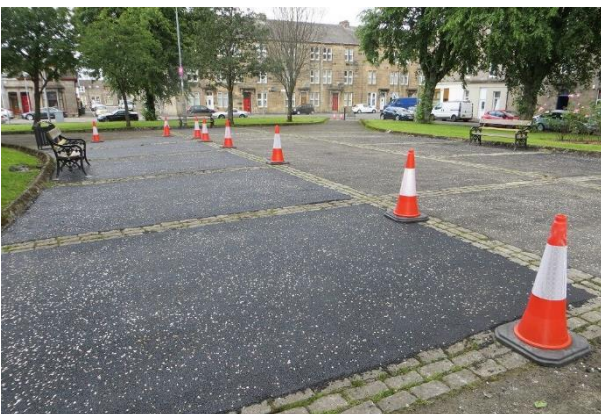
To Knoxland Square itself, the hard landscaping was a mix of tarmac and modern paving with some damage. Paving is currently being replaced by tarmac. There are aged concrete kerbs around the perimeter of the grass sections which are in poor condition with many loose and lying out of position. Benches are in poor condition and other street furniture such as grit bins, bollards and waste bins are of standard design.

Figure 16 Knoxland Square: resurfacing underway in June 2017.

Knoxland Square is a significant feature and community asset; however, the condition of hard landscaping and street furniture is poor. The use of tarmac for resurfacing is detracting (see Figures 16-18).

- Hard landscaping, roads and pavements should be maintained and where repair or resurfacing is required, careful consideration should be made to the choice of materials respecting the original character of surfaces. There should be a reluctance to approve the removal of green space for hard landscaping.

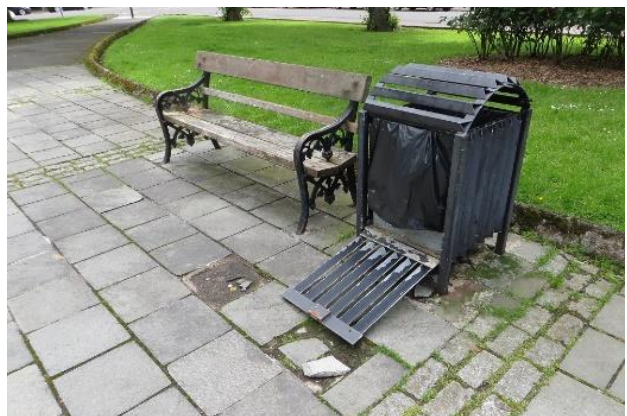
Figure 17 Knoxland Square: paving, bench and waste bin in poor condition.

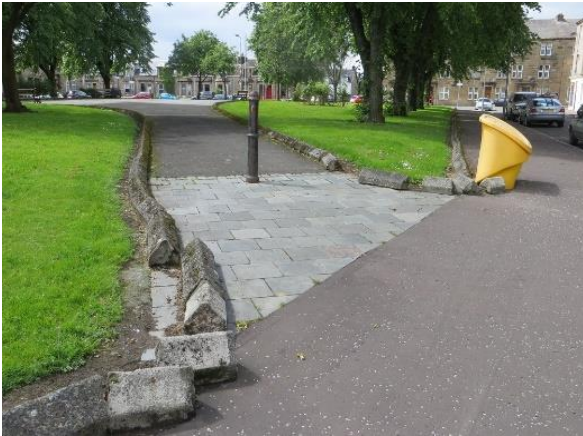
*Figure 18 Knoxland Square – mixture of tarmac and paving surfaces, concrete kerbs in poor condition and loose.*

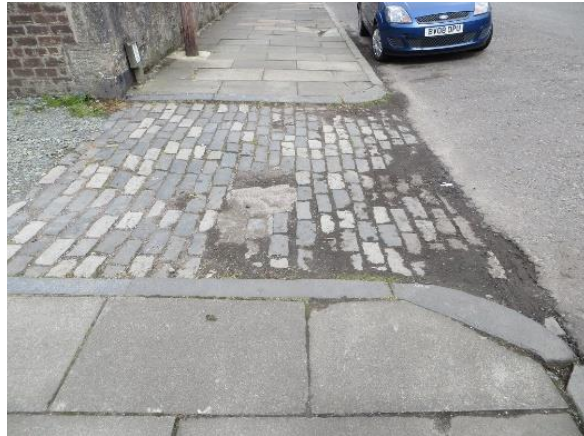
*Figure 19 Traditional setts at entry to Victoria Street lane (just outside conservation area).*

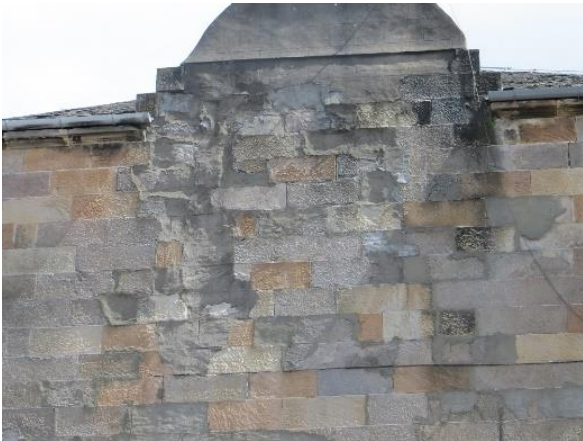
A number of gable walls show signs of water ingress at high level below chimneys. This may be the result of a number of repair and maintenance issues (erosion of pointing or stone, defective flashings around the chimney, defect haunching, chimney pots not vented or capped appropriately). In a number of cases chimney stacks have been removed and modern vent pipe protrude from the roof.

*Figure 20 Stone erosion at gable chimney poorly repaired in cement.*

It is important that historic buildings are adequately maintained and repaired using traditional materials and techniques and property owners are encouraged to get specialist professional advice.

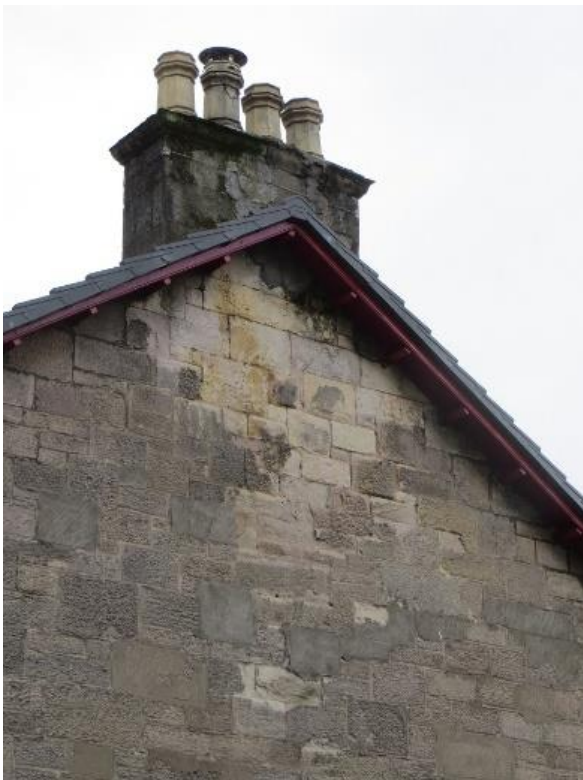
*Figure 21 Stone erosion at gable chimney and defects to chimney above.*

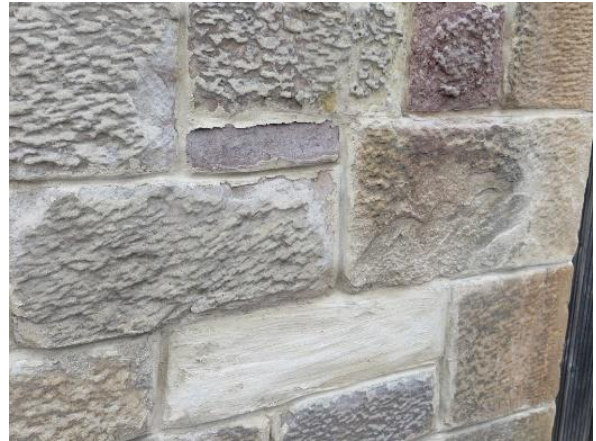
Masonry on several buildings and boundary walls is in poor condition and/or has been repaired inappropriately including use of cement mortars, 'plastic' stone repairs and poor working methods. Attention should be drawn to the risk associated with impermeable materials and finishes and opportunities taken to repair in traditional materials when they arise. Disrepair and stone erosion is particularly noticeable at the pavement level to tenements and other walls built directly onto the street. Damage is likely due to water splashback from the hard surfaces onto the stone, and salt efflorescence from continued wetting and drying of the sandstone.

*Figure 22 Stone erosion at gable poorly repointed in cementitious mortar and plastic stone repair.*

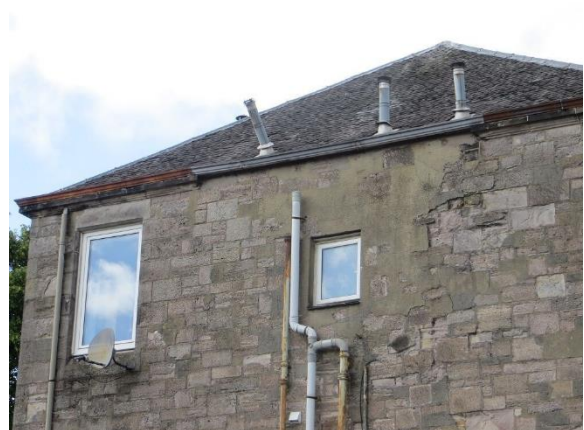
The majority of original windows and a significant number of entrance doors have been replaced, generally in inappropriate fenestration design and materials. Replacements in uPVC, aluminium, and/or non-traditional fenestration patterns and opening methods have a negative effect on both the character and quality of individual buildings and a cumulative impact on the character of the conservation area as a whole. Tenements and terraces would originally have had the same window and door designs; however, varied replacement has left a lack of continuing over these frontages.

*Figure 23 example of window replacement in non-consistent design and opening method and gable chimney removal with poor repair below.*

use materials which are high quality, durable and which complement the palette of materials traditionally found in the conservation area (the use of UPVC, aluminium, concrete tiles or other non-traditional materials are not considered appropriate).

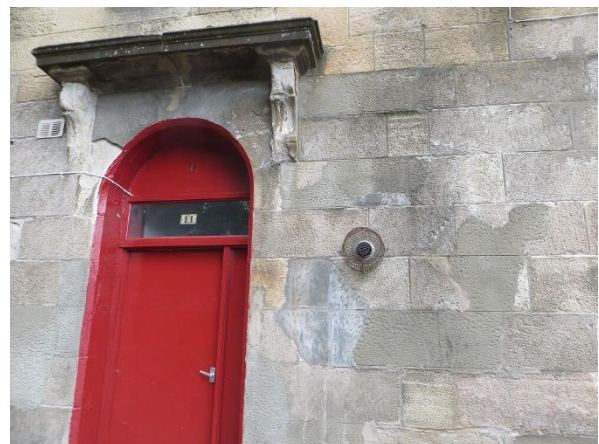
*Figure 24 Poorly executed cementitious stone repairs, stone erosion to door lintel, and obtrusive vent.*

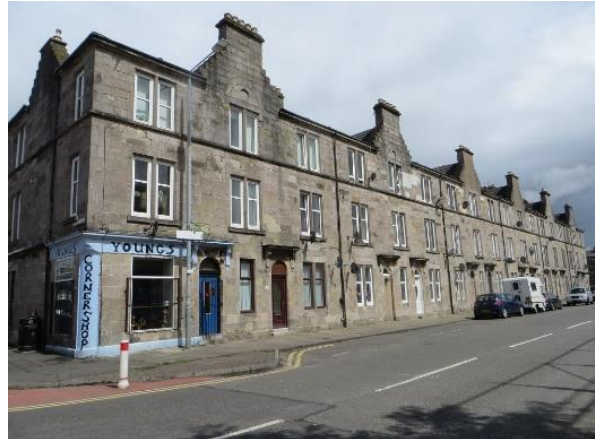
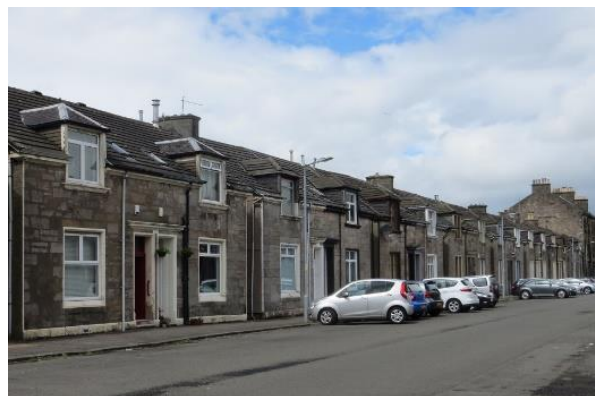
*Figure 25 Above: Tenement block on Castlegreen Street – very similar to the Knoxland Square block.  
Below: Semi-detached houses on Wallace Street to the same design as Bruce Street.*

However if option 1 is not followed, then, as a minimum, it is recommended that consistency is achieved by including full street blocks i.e. Nos. 44 -52 Victoria Street, Nos. 11-17 Victoria Street and Nos. 20-26 Bruce Street (both the same design as the south side of Knoxland Square); Nos 27-37 Bruce Street, Nos. 4-10 Bruce Street, and remainder of tenement blocks on Victoria Street. It is difficult to argue why an identical house on one side is in the conservation area, and its neighbour is not.

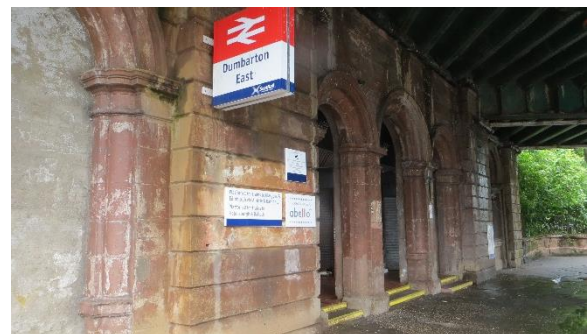
Also on Glasgow Road is the Dumbarton East Railway Station (see Figure 26) which is contemporary to the tenement development. Its channelled ashlar sandstone façades, grand arched entrance, as well as the original stone boundary walling and traditional railings make a significant contribution to the streetscape and character of the area, despite its current poor condition. It would be important to include the original station structure if the conservation area were

Figure 26 Dumbarton East station.
