# DUMBARTON CENTRAL STATION

## *Conservation Management Plan*

### *Volume One*

**FINAL** May 2019

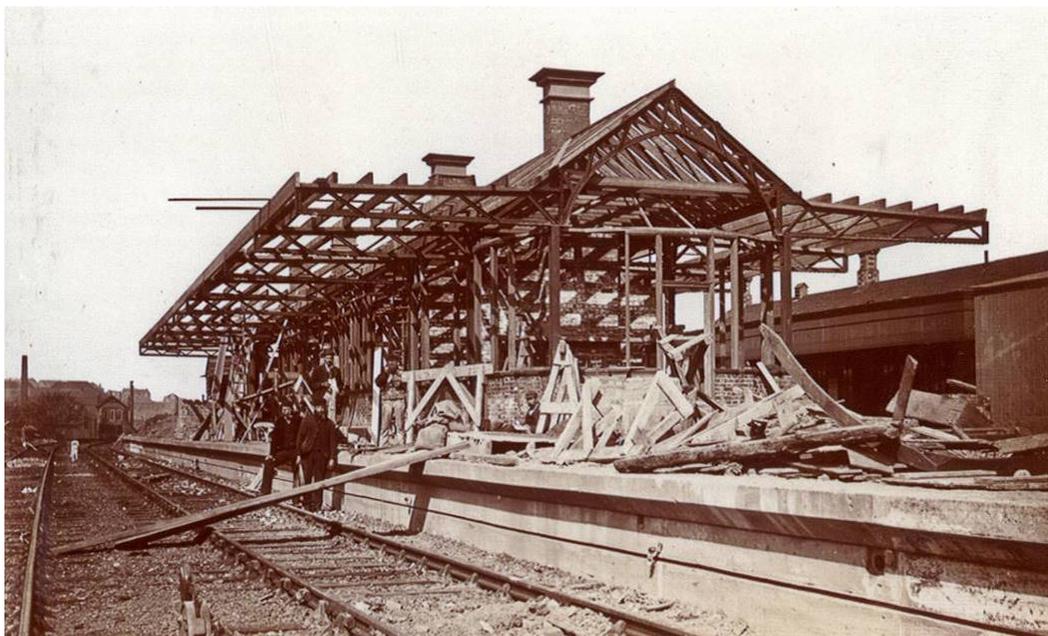
Figure 17 c.1896 photograph of the south platform during construction.<sup>64</sup>

A c.1896 photograph of the station (figure 17) shows the south platform building under construction. The image is believed to be a view looking west from the railway tracks on the south side showing the south platform building that we know was completed first. It is interesting to note that to the right of the photograph, a large open-sided building that appears to be a large shed is in the location of the current north platform building and it would appear to be the only image found during the completion of this report to show, at least in part, the 1874 north platform building configuration.

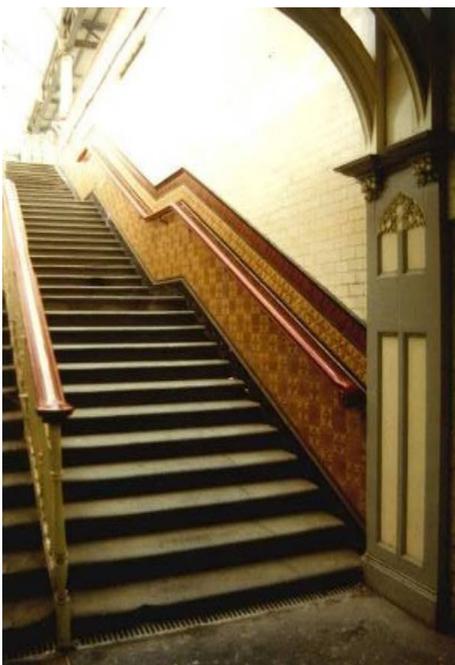
Figure 21 c.1981 Foot of the north stair.<sup>68</sup>

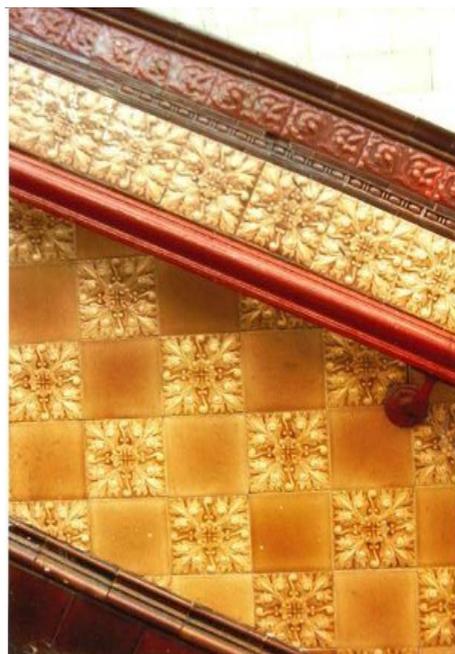
Figure 22 c.1981 stair tile detail.<sup>69</sup>

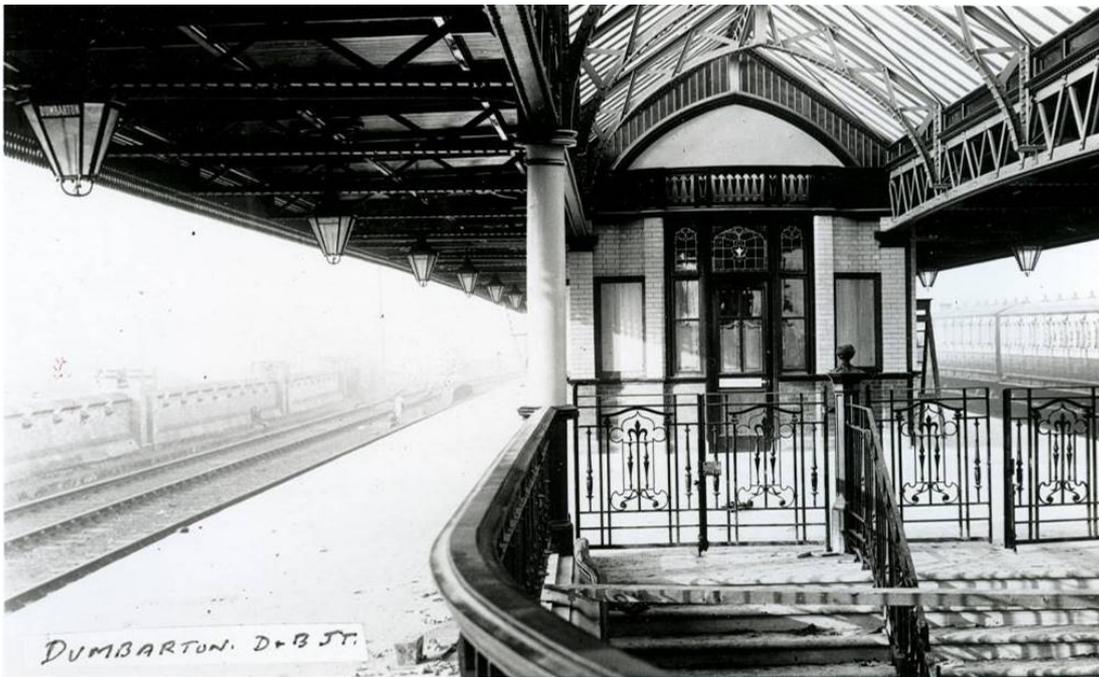
**Figure 26** c.1935 image of the south platform of Dumbarton Central Station showing the former hanging lanterns labelled with 'Dumbarton' and the now-enclosed south stair and decorative wrought iron gates.<sup>73</sup>

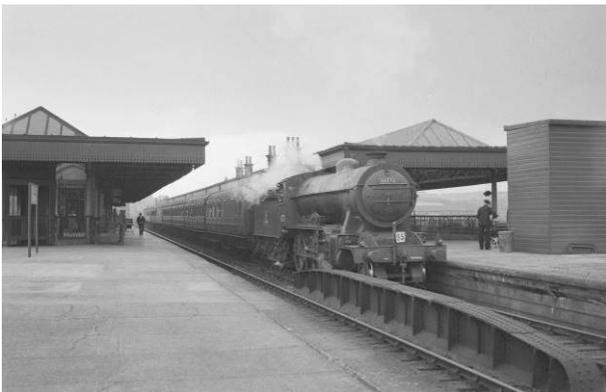
**Figure 27** c.1950s View looking northwest towards the north platform from the west end of the south platform showing the hoist building on the north platform to the right of photo.<sup>74</sup>

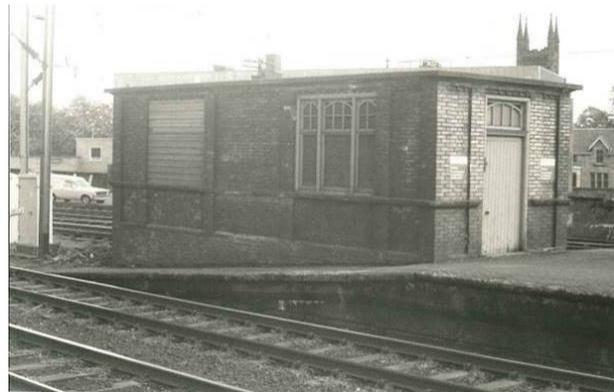
**Figure 28** Mid-late 20<sup>th</sup> century image of service building at end of the south platform.<sup>75</sup>

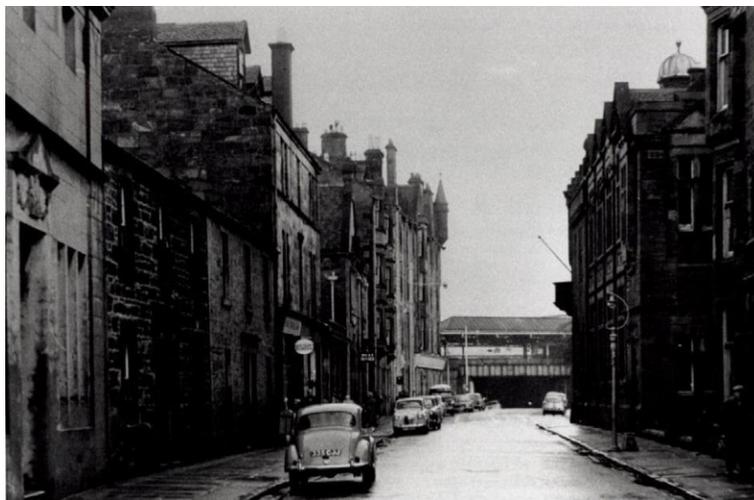
**Figure 29** 1965 photograph looking north along Upper College Street toward the station prior to roadworks and demolition.<sup>76</sup>

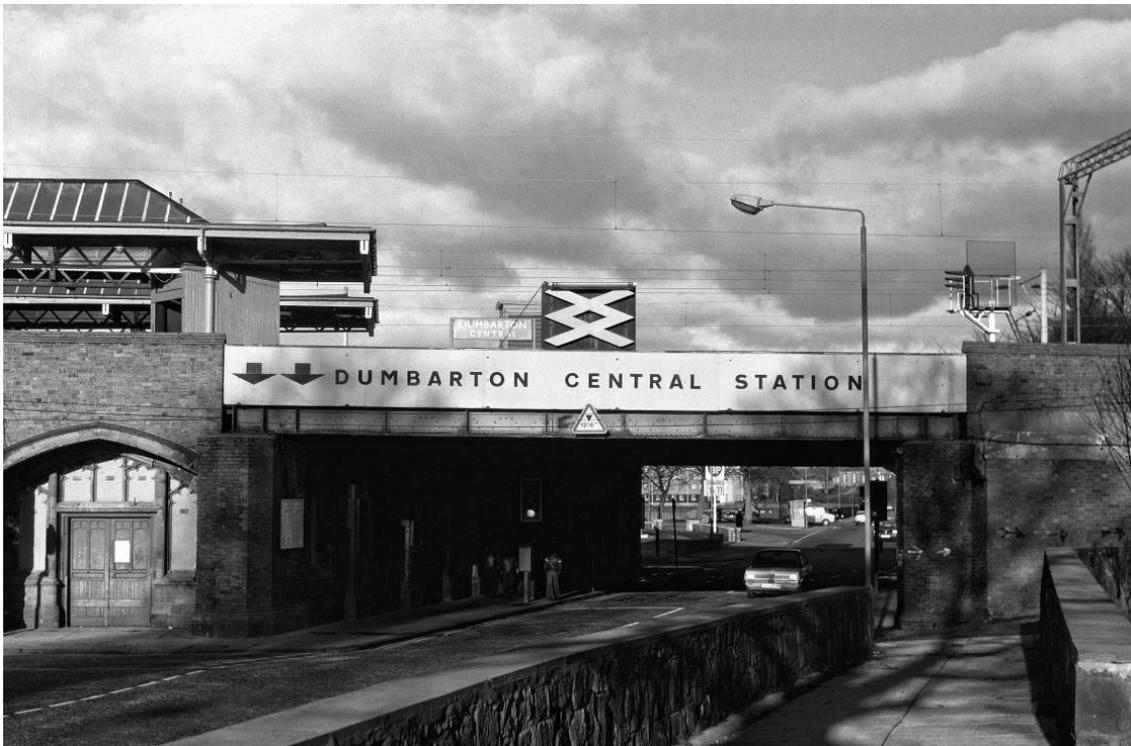
**Figure 31** 1978 photograph showing parcel lifts as viewed from Church Street.<sup>78</sup>

A photo from 1978 (figure31) shows the parcel lifts on both platforms (timber structures above-remains below). They appear to have been removed after this date. The service building on the south side was still extant in the early 1980s.

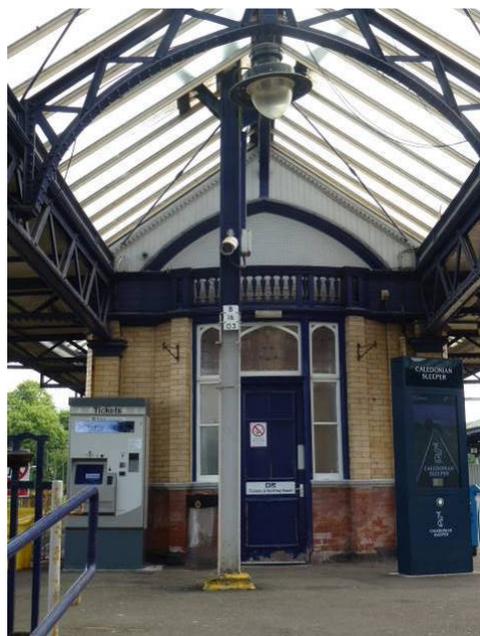
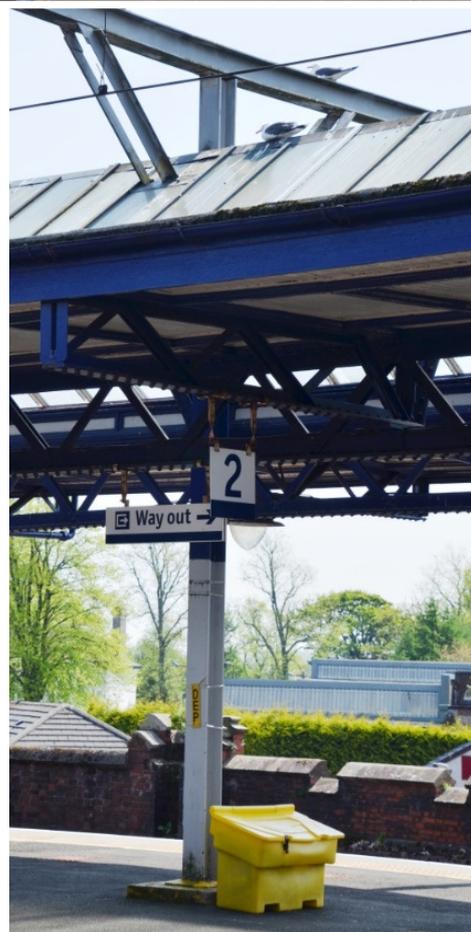
**Figure 32** Electrification stanchions at top of access ramp (top) and on platform (bottom<sup>81</sup>)

#### *Electrification of the Lines (see figure 32)*

Some later interventions have been noted at the station that have an adverse impact on the character of the station buildings. These include the installation of stanchions for the electrification of the railway line, and the more recent insertion of a toilet 'pod' within one of the original waiting rooms.

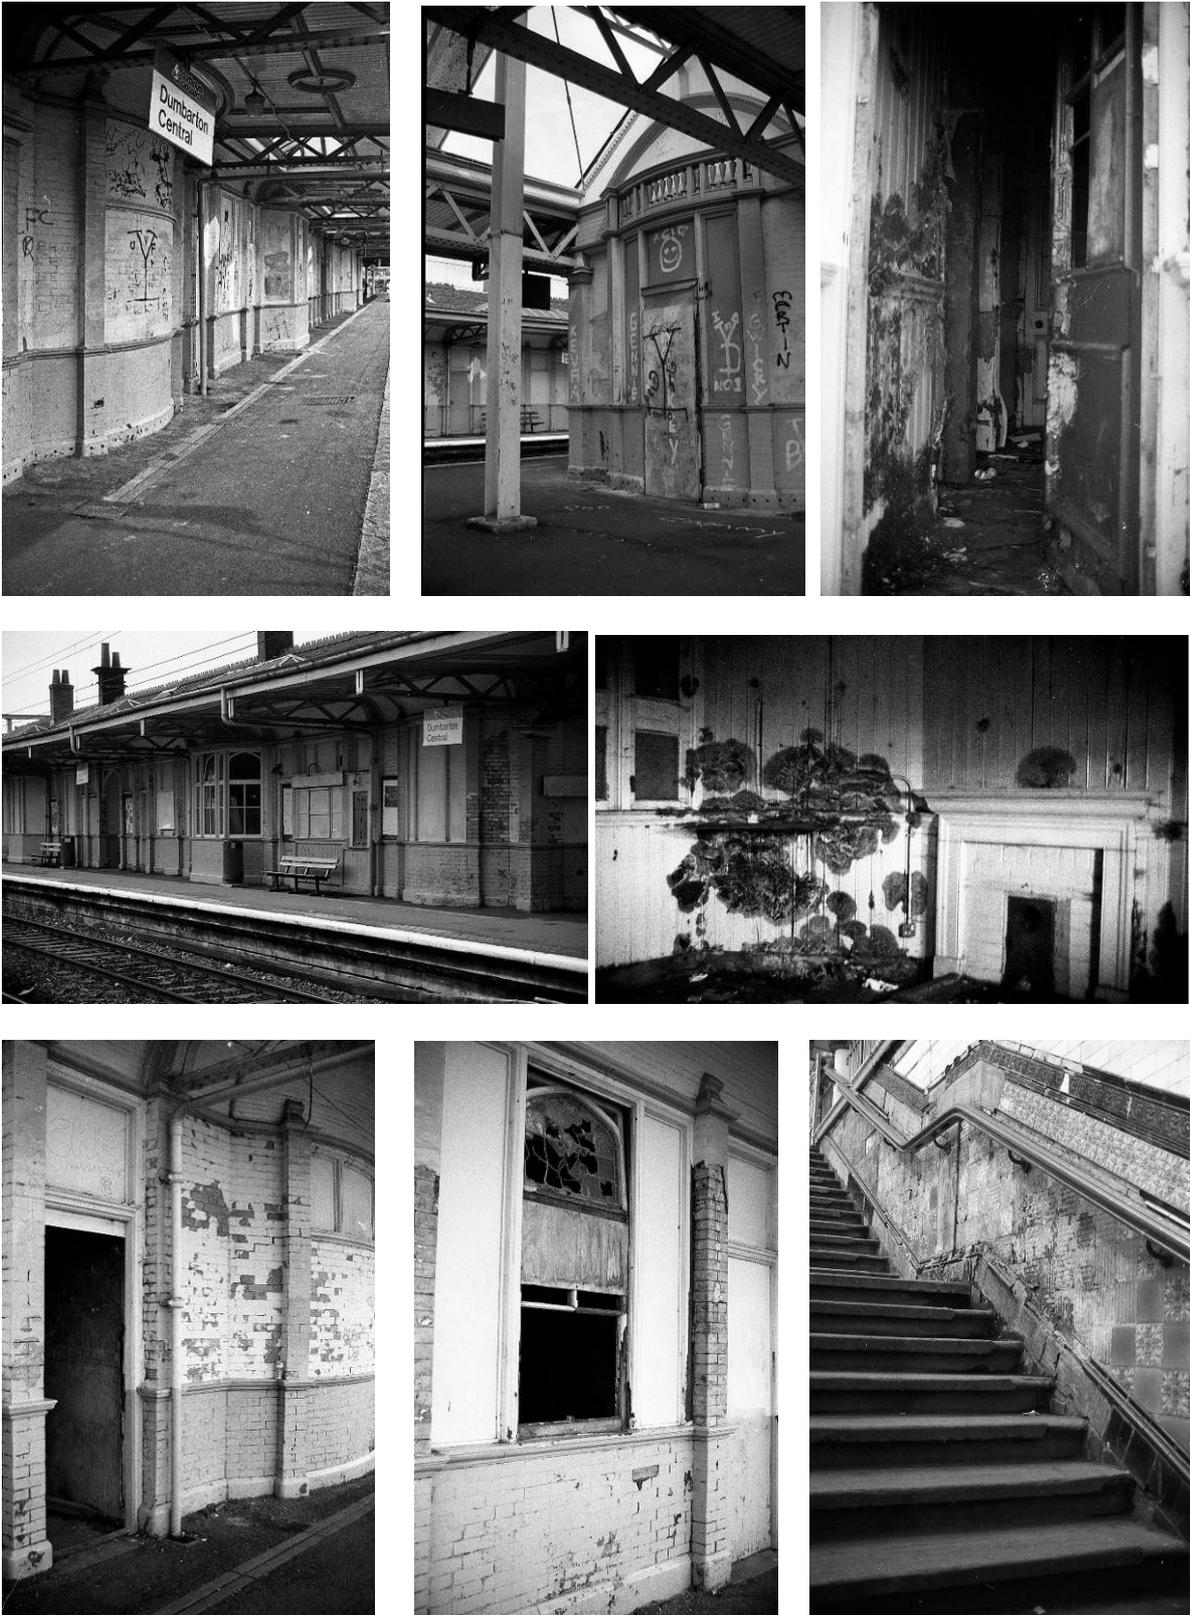
**Figure 37** Photographs taken in 1989 showing the derelict state of the station at this time prior to refurbishment works.<sup>82</sup>

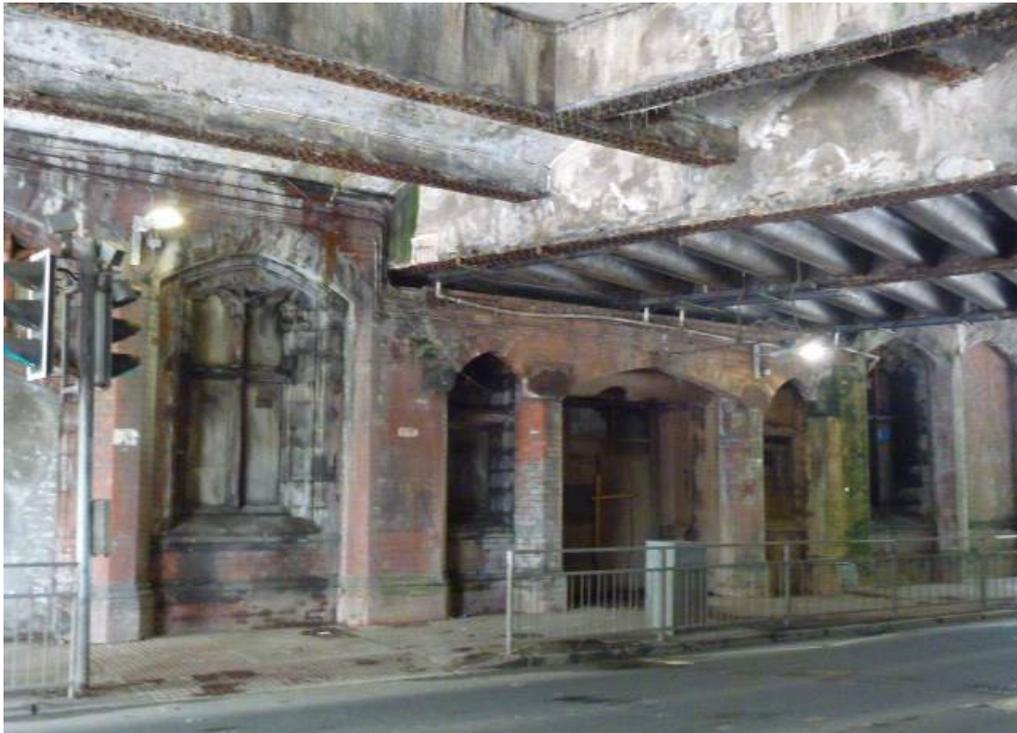
Church St. elevation and bridge deck (2018)

**Figure 43** Water ingress saturating the building fabric below the tracks and high moisture levels in the fill compounded by cementitious coating causing efflorescence on the embankment walls

At the Church St elevation, water run-off is evident in the pattern of erosion, the pointing has been washed out of the soft sandstone dressings and some of the moulded and tracery detail has been lost. The openings have been bricked up and rendered externally with cement, which will accelerate decay in adjacent stone.

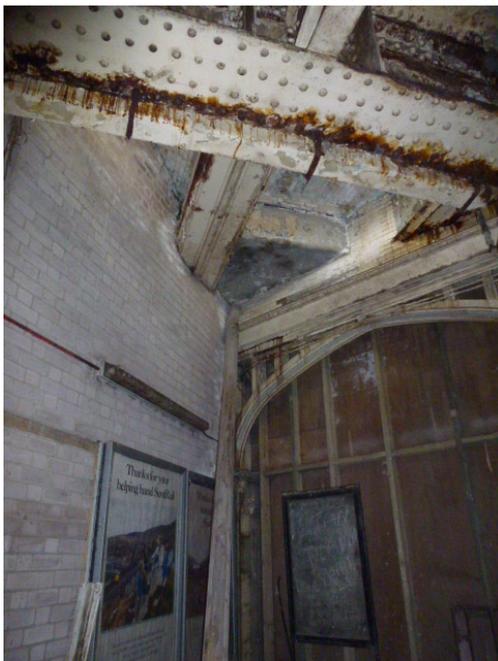
Corrosion in steel structure at foot of south stair

Remedial measures, such as introducing weepholes or replacing the render with a breathable coating, may slow down the process. But until the source problem is addressed the masonry and the embedded steel structure supporting the platforms will continue to decay.

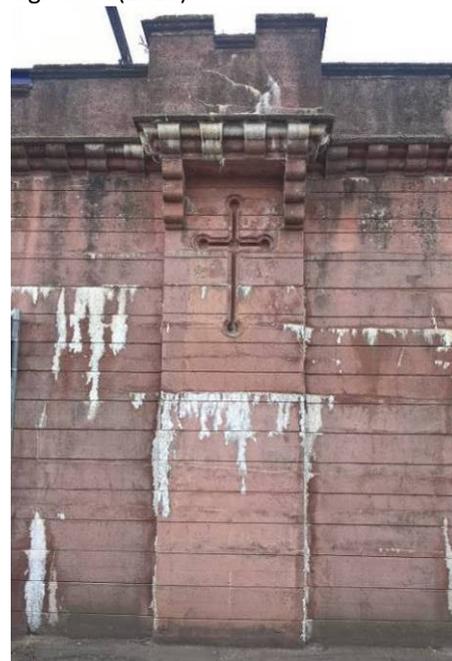
Efflorescence on north embankment walls

High moisture levels in the fill are made evident by surface efflorescence on the embankment walls and water ingress in the underpasses. The primary source is presumed to be from the track bed above. The embankment walls were built in different stages of the station development, reflected in the detailing. The north wall on Bankend Road is of an earlier date. Both the north and south walls have been coated in a cementitious render, which extends to cover the parapet on the north wall only. The south wall has a battered profile. The coating is exacerbating the problem by retaining the moisture in the fabric, thereby accelerating decay. Where the brick is exposed, dark staining above the windows indicates moisture at track bed level.

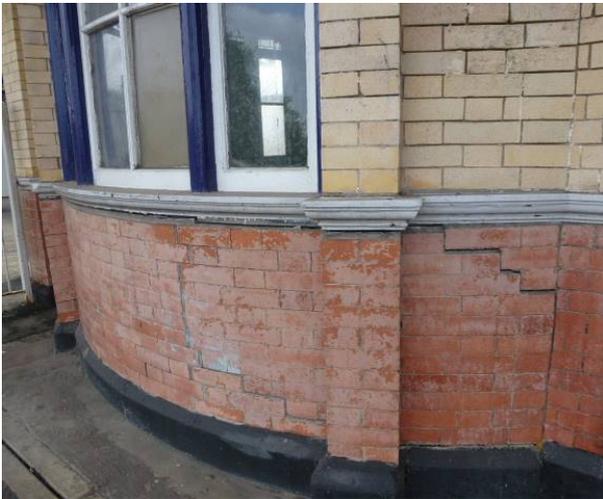
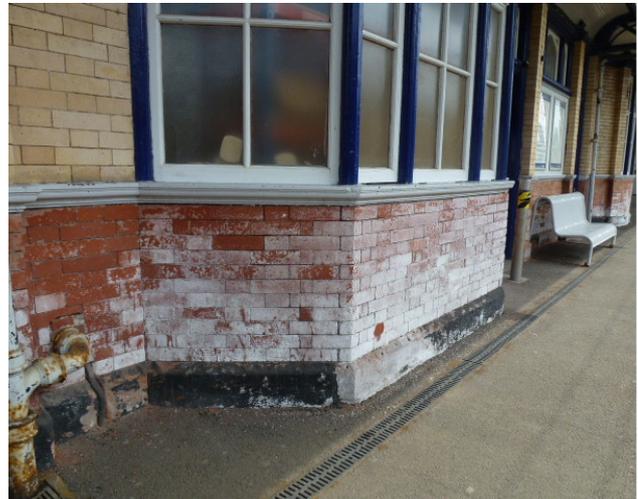
**Figure 44** Platform buildings: showing movement, coating on brickwork, open joints, efflorescence, stone base, and drainage channel.

The external walls of the platform buildings were constructed in good quality pressed bricks, red below the dado rail and yellow above with fine joints, built off a stone base course. They are afforded some protection by the canopies. The masonry was painted in the past and has been aggressively cleaned, causing surface damage. There is very little mortar present in the joints. A waterproof coating was then applied to the brick, preventing drying out. Some red bricks have lost the fireskin, probably due to trapped moisture followed by a frost. The coating is now wearing off, creating an uneven surface appearance.

A chemical damp-proof course has been injected into the red sandstone stone base, which was painted black. The platform has been resurfaced in an impervious finish (Tarmac), built up against the stone. The sandstone is eroding and there are high levels of efflorescence on the red brick. The soft stone is vulnerable between the strong brick and the impervious ground surface. The coatings, chemical DPC and any cementitious mortar will trap any moisture present and compound the problem. The gutters on

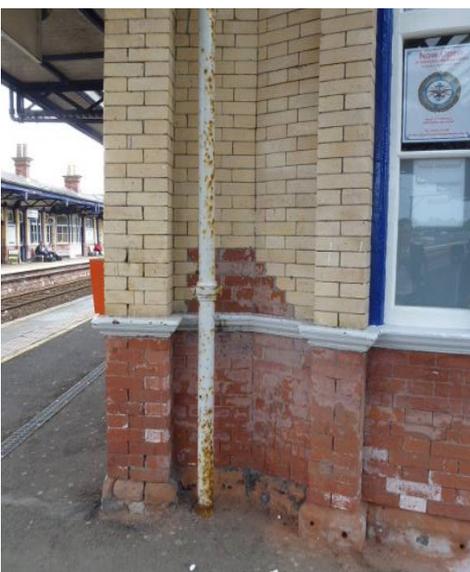
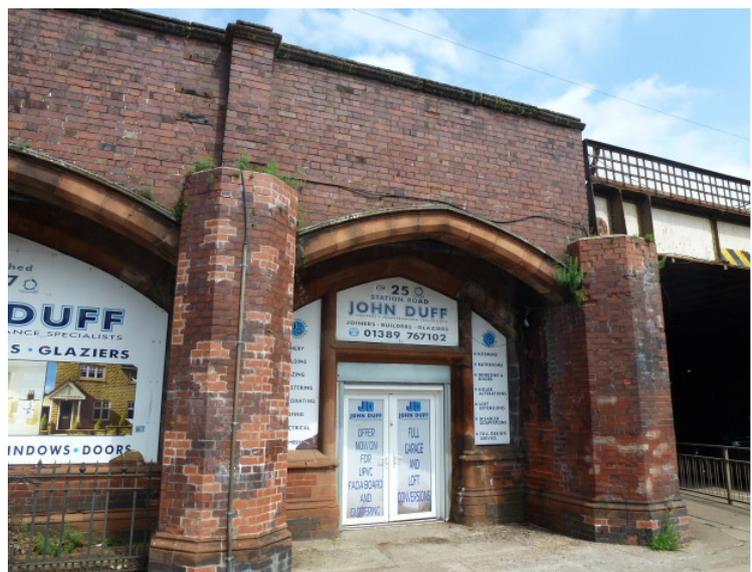
**Figure 45** Inappropriate repairs - injected chemical DPC (L) and Non-matching brick replacements & loss of detail at Station Road (R)

The brick piers to the embankment walls, either side of the bridges at Church Street and College Street, have been reduced in height and remain uncapped with vegetation growing out of the top. The parapets over the first bay of ground floor rooms have been rebuilt without crenellations or corbel details. Brick replacement has been carried out to the piers using non-matching brick and mortar. The resulting appearance is very poor.

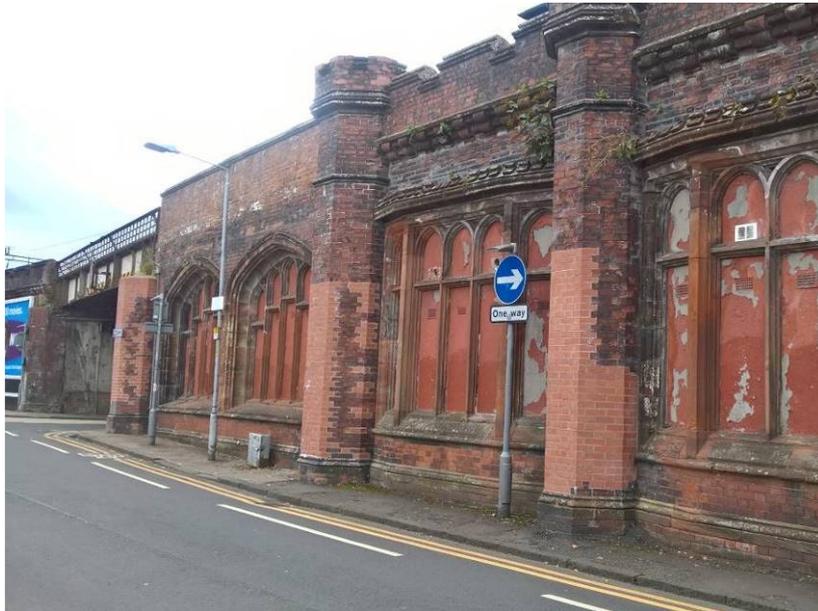
**Figure 46** Bankend Road non-matching brick replacements and loss of detail at bridges

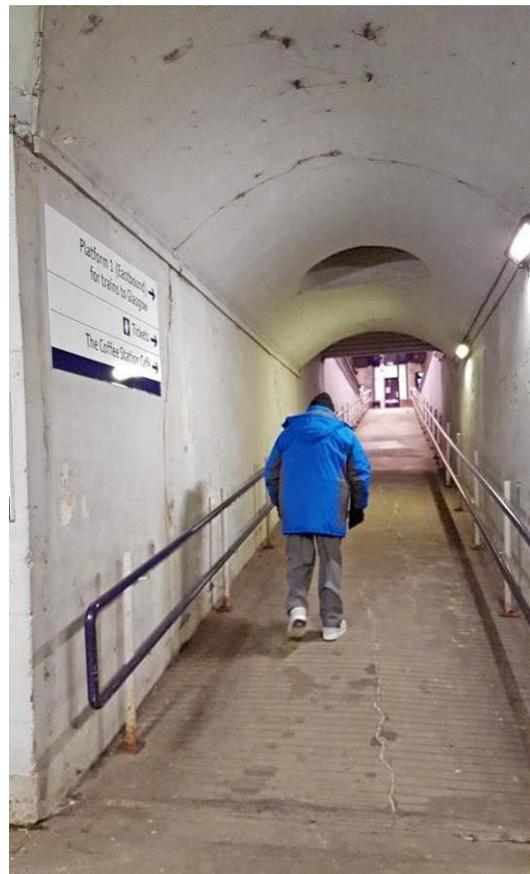
**Figure 47** Access ramp and signage

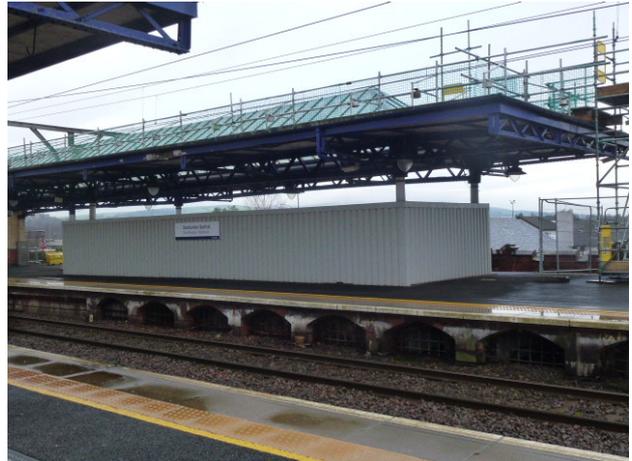
**Figure 48** Stair enclosures and windows between platform and track

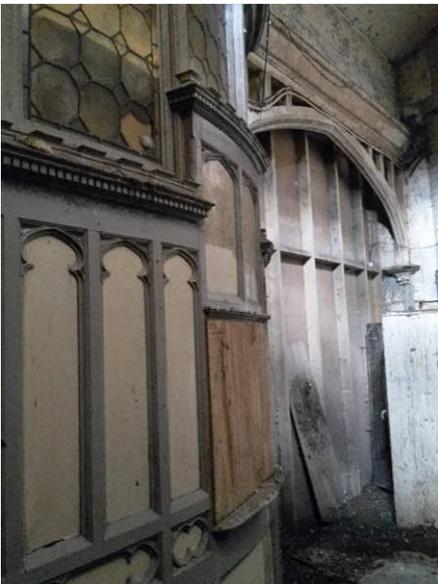
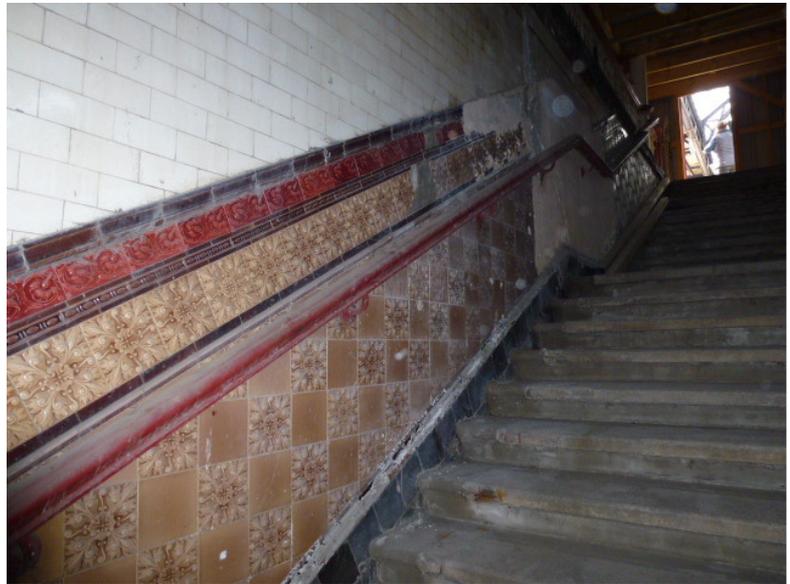
**Figure 49** Ground floor booking office screen (L) and north stair (R)

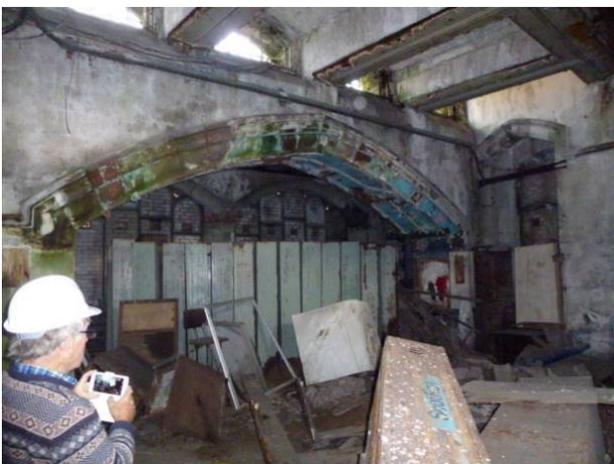
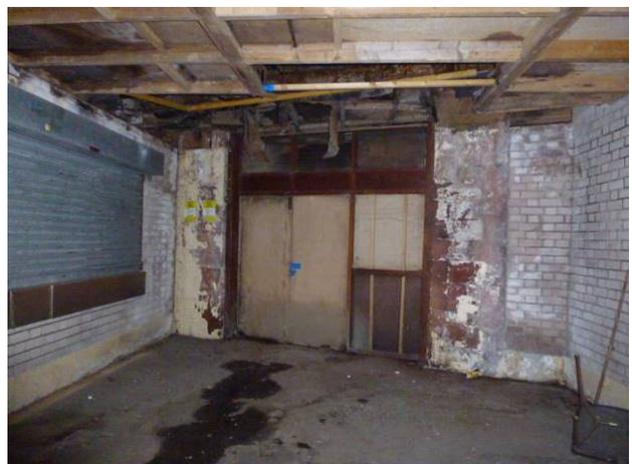
**Figure 50** Ground floor northeast room (L) and east entrance with suspended ceiling frame (R)

Another interesting feature noted in a space referred to as the 'Provost's Room' in the northeast corner room of the ground floor reputedly retains a decorative fireplace that will require further investigation, as it was not visible at the time of inspection

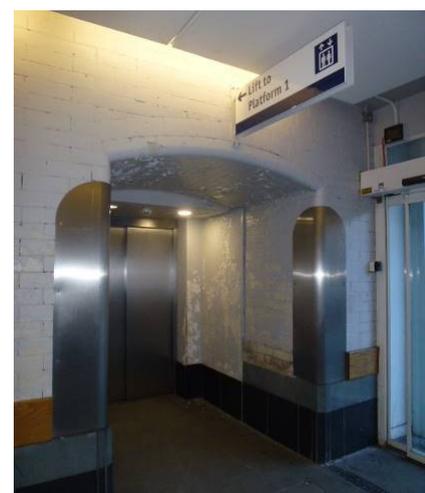
Figure 56 Lifts in underpass at Paisley Gilmour Street Station

The recommendation, at this time, is to install lifts at the foot of the ramps in the underpass at the west entrance. The advantages are that it is already in daily use, and the impact on the listed building fabric would be minimal. (The structure supporting the platforms at the east entrance is complex and not enough is yet known about the original layout). Ticket machines will be required on both platforms *or* in the underpass. The work should include: resurfacing the ramps and restoring the glazed brick; redecorating the underpass and installing new lighting. The existing water management system should be replaced, if required.
